CABINET

Corporate Non-Housing Property Portfolio: Required Building Works

22nd January 2013

Report of Head of Resources

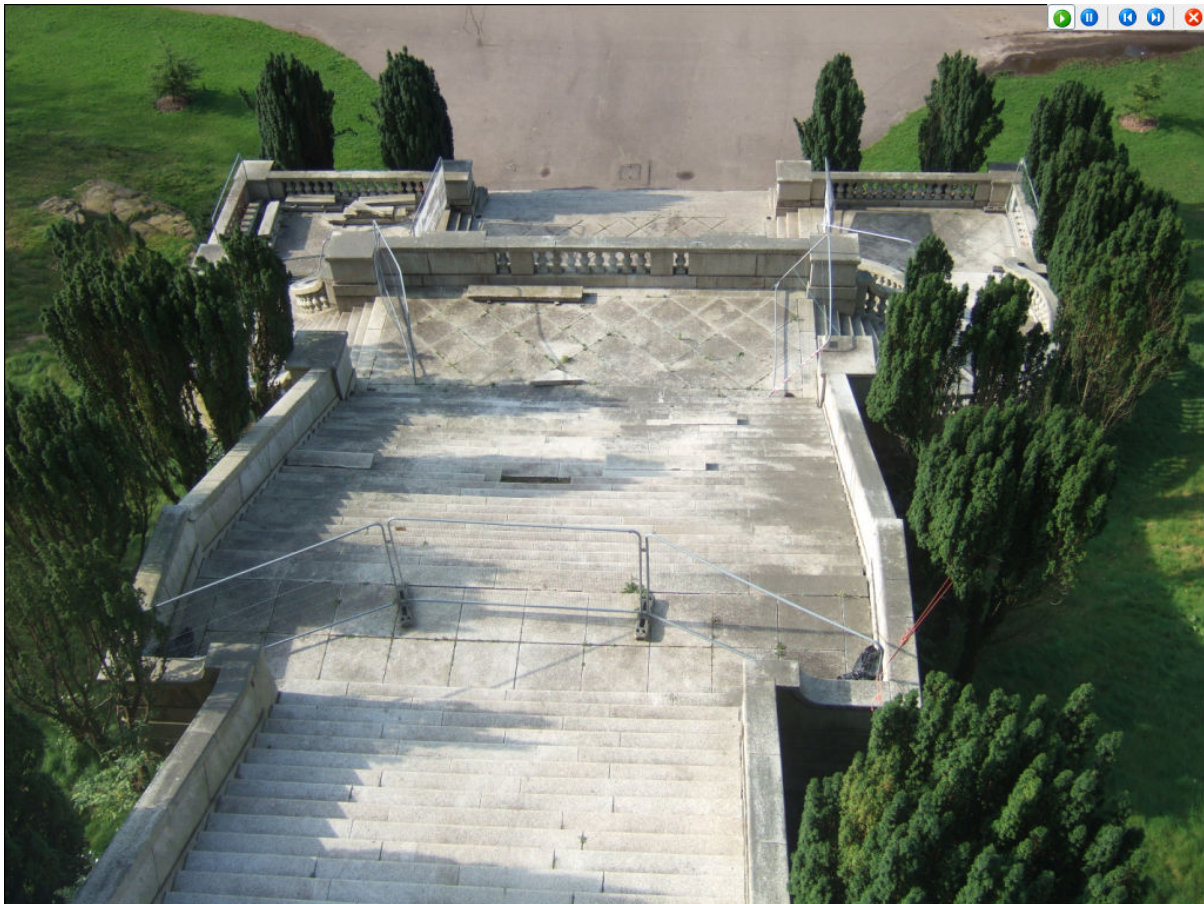
Condition: D
Priority: 1
Time Scale: 2013-2014

Defect:
Corroding/failing support structure, uneven steps. Repair works in progress with a projected cost of £180K.

Remedy:
Complete repairs

Estimate: £184,800.00
