MUSICIANS CO-OP

CONDITION REPORT

Our ref: L35353/SW/TP

**MUSICIANS CO-OP
LODGE STREET
LANCASTER**

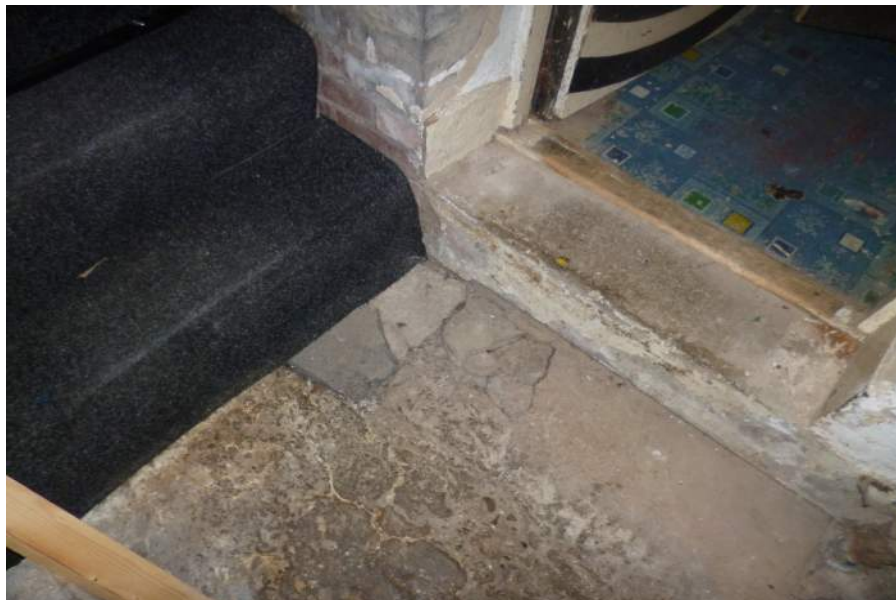
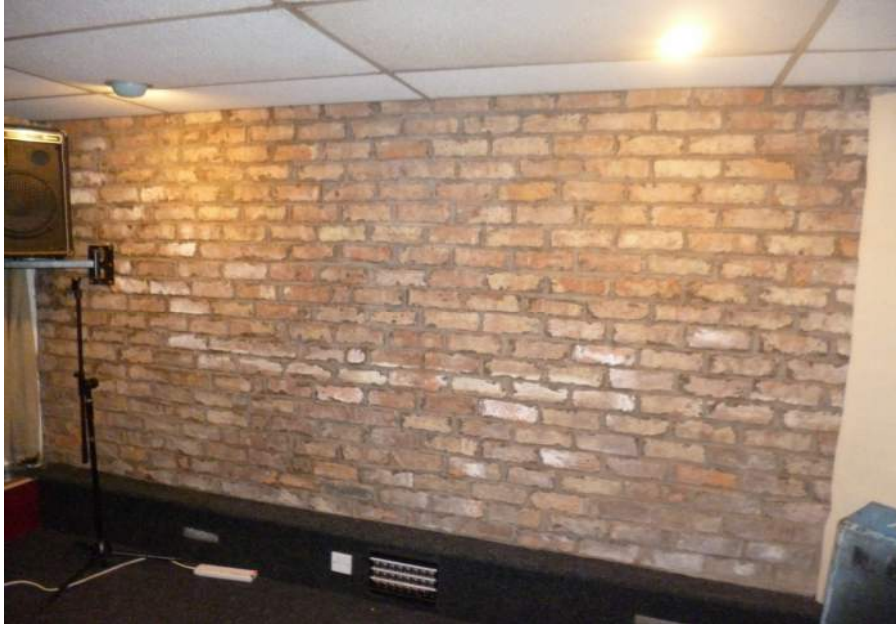
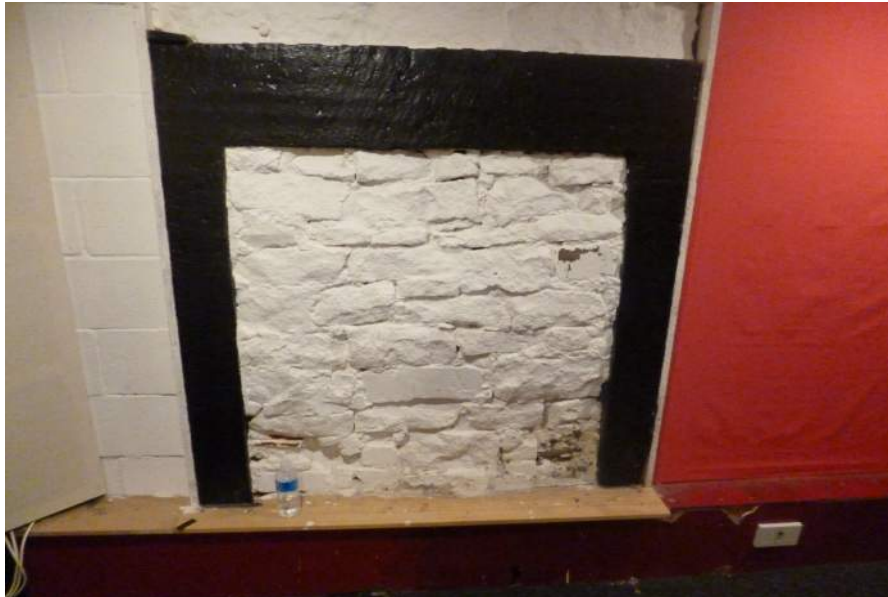
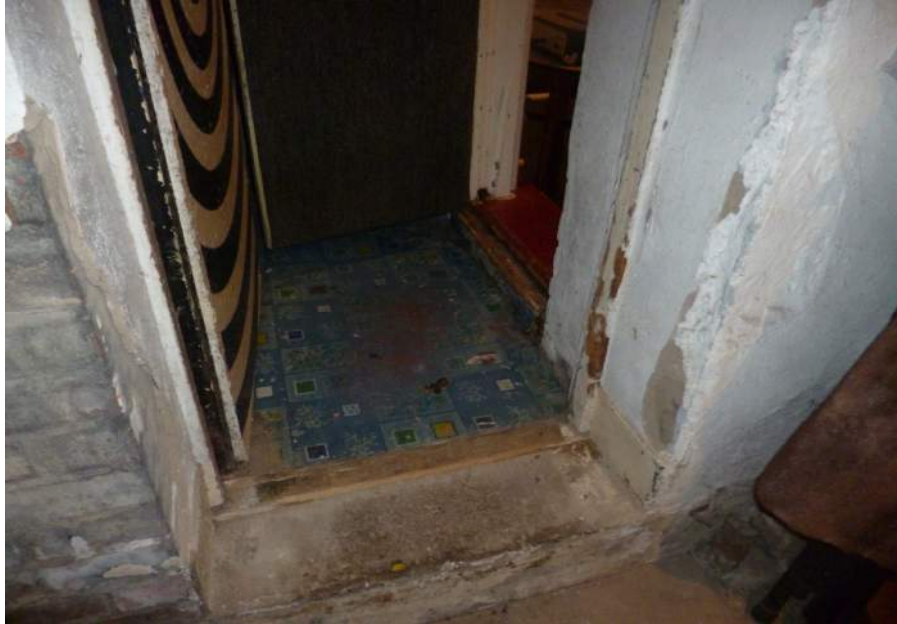
003 Ground floor office and adjacent corridor	External wall plastered mass with areas of damage. NOTE: plaster is 20-30mm thick in areas. Concrete floors with cracks. Internal walls in areas solid up to approx. 1.5 with stud above. Consider original panels with glazing inserts. Decoration is generally in good condition. Photo ref. 461, 462, 468.	Sections of plaster fallen off. Knock off loose plaster. Investigate possible damp and patch repair. Investigate existing to confirm if lime mortar.	1C
		Original timber panels/studs - remove any damaged glass panels.	1B
		Carry out local crack and damage repairs with high strength non-shrink grout.	1C
		Redecorate	4
004 music room, ground floor, original terrace house.	Concrete floor with carpet finish. Brick outside wall in good condition. Internal wall block masonry. Fireplace has been filled in with random masonry - no vent. Suspended ceiling with rough board above acting as a soffit. Large amount of services in void(status unknown). Ground floor levels vary - step is a trip hazard. Photo ref. 462, 464, 466, 468.	Add vent to original fireplace.	2

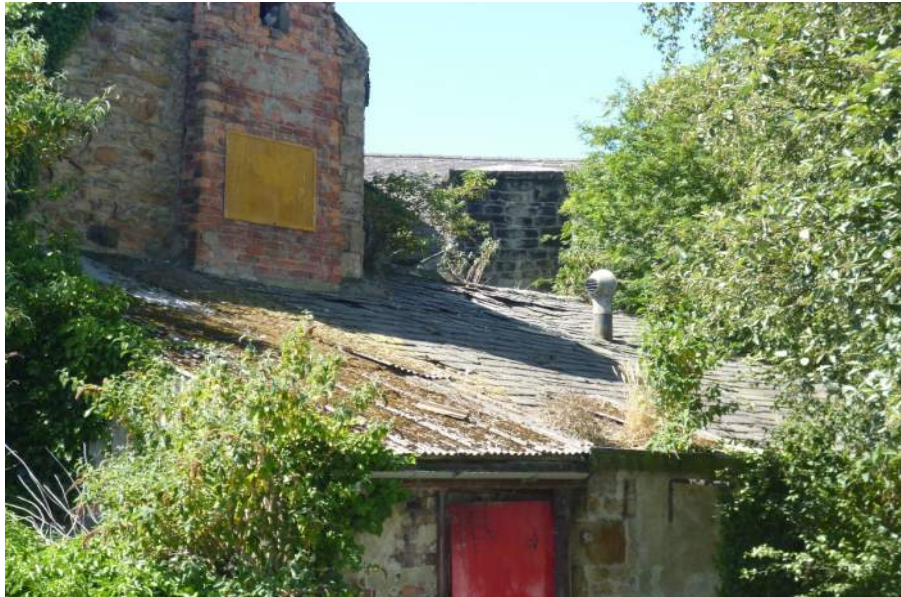
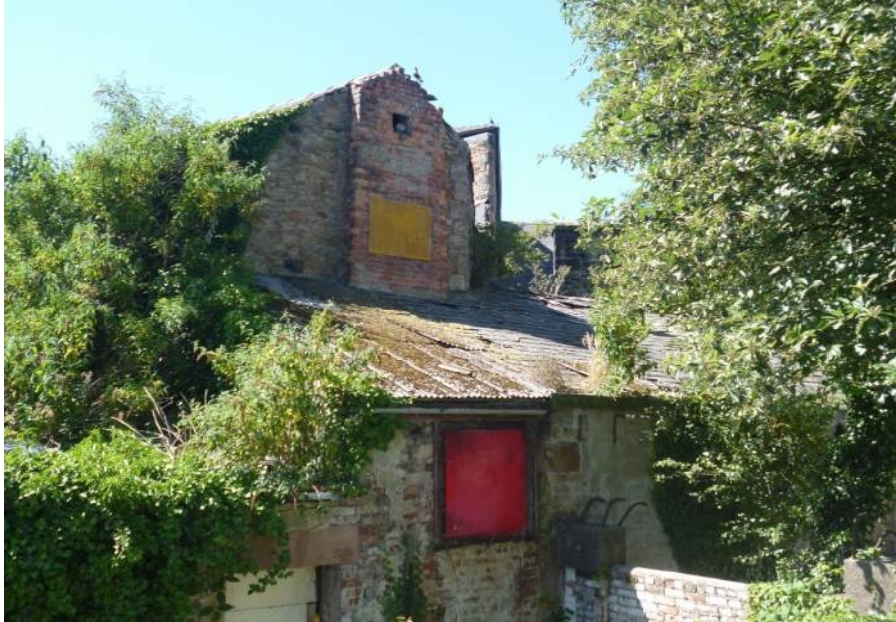
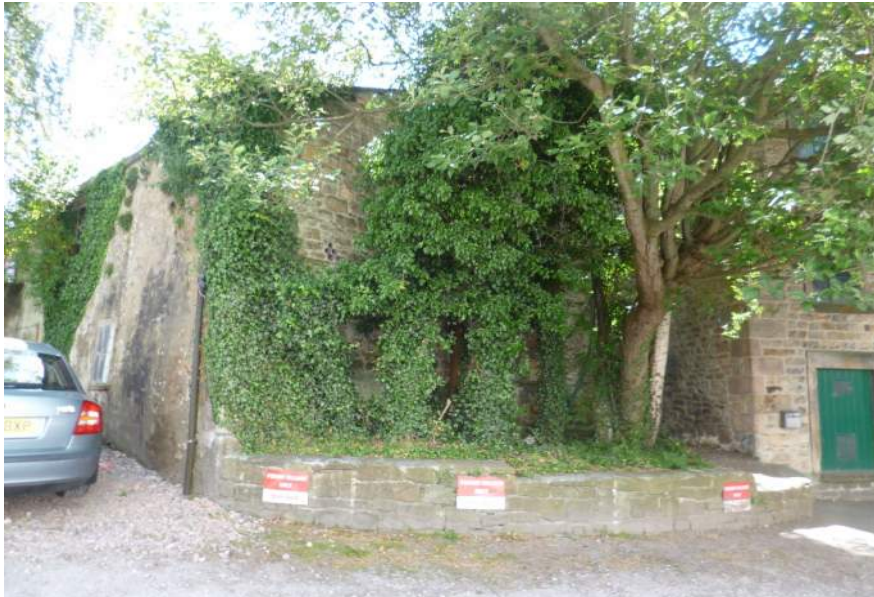
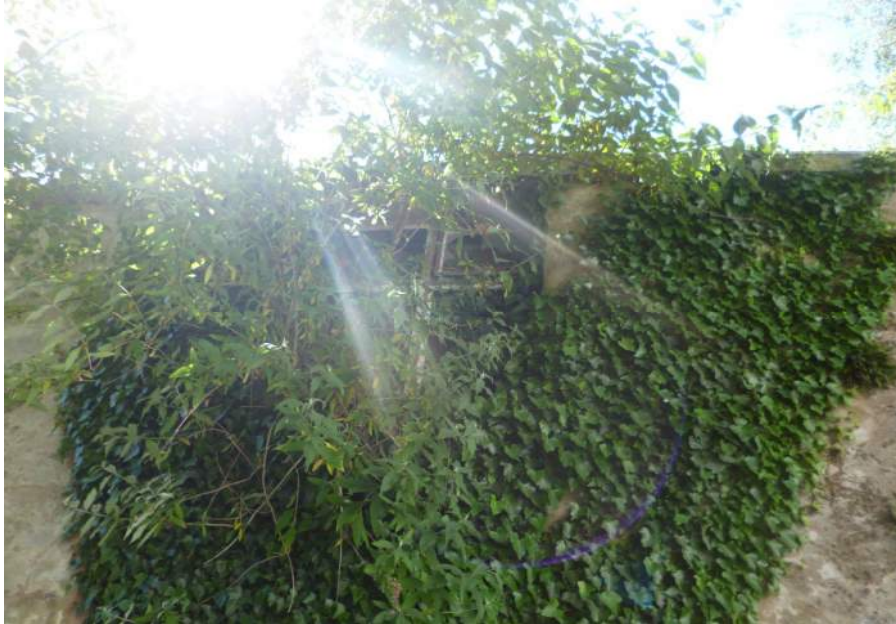
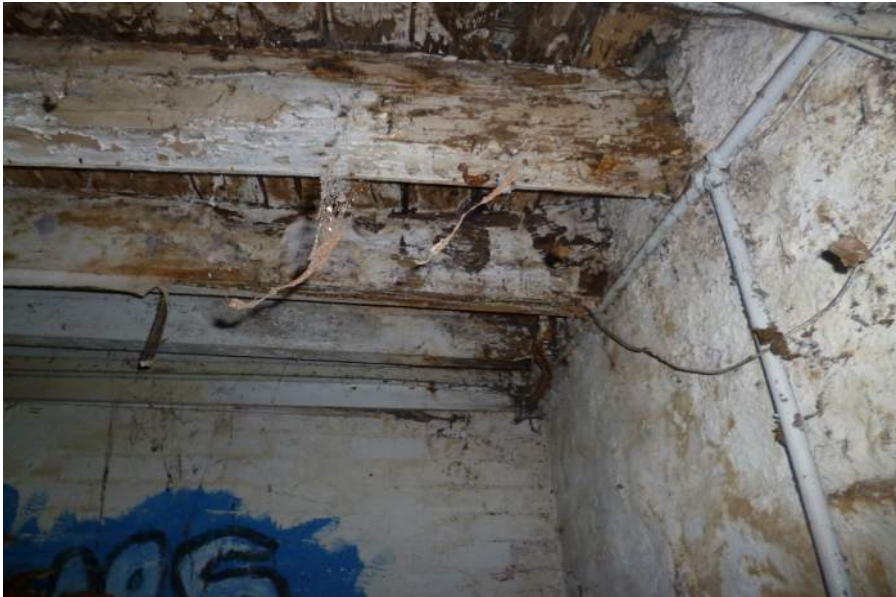
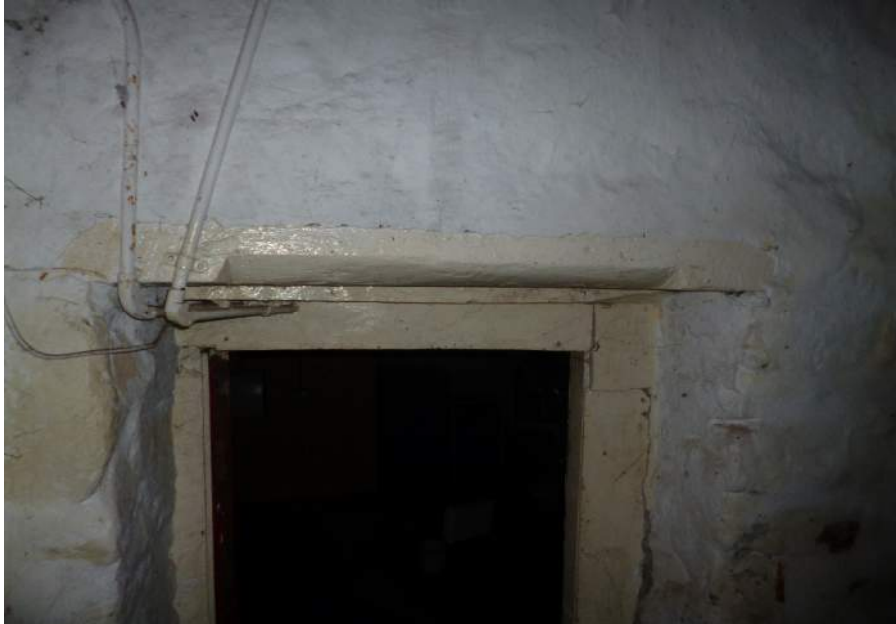
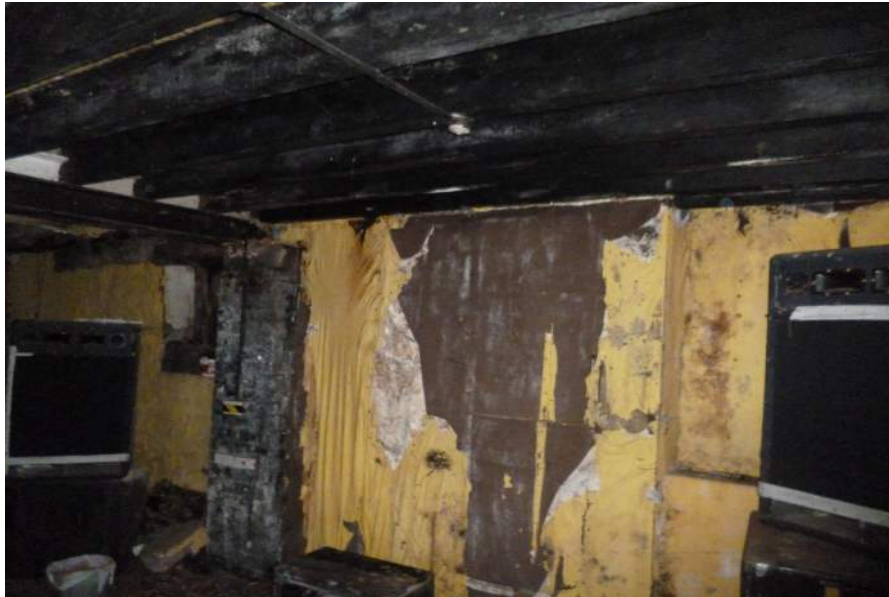
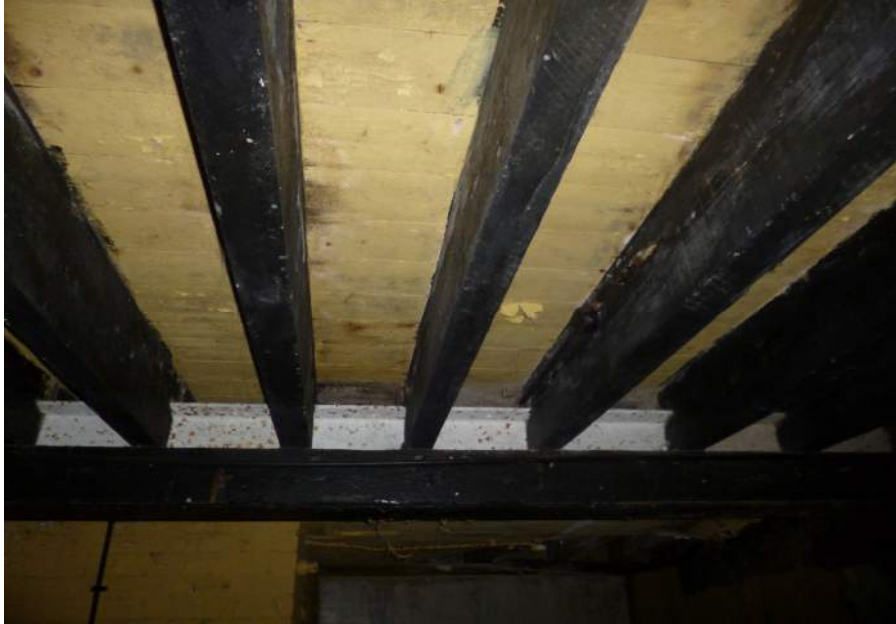
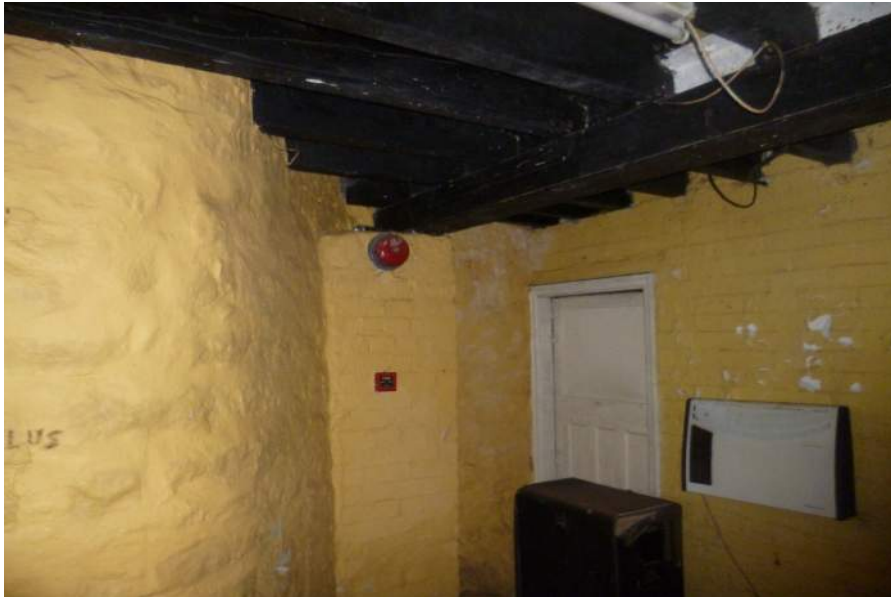
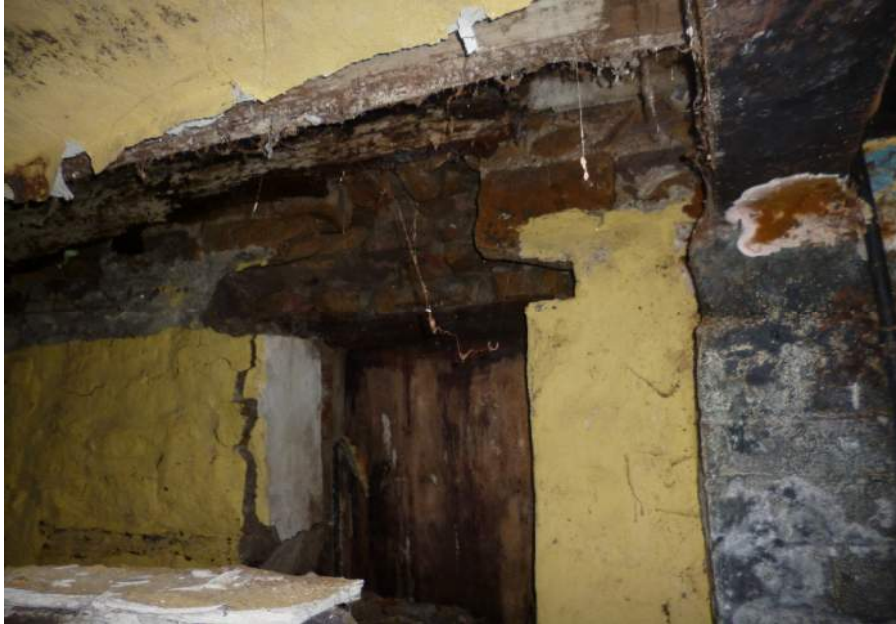
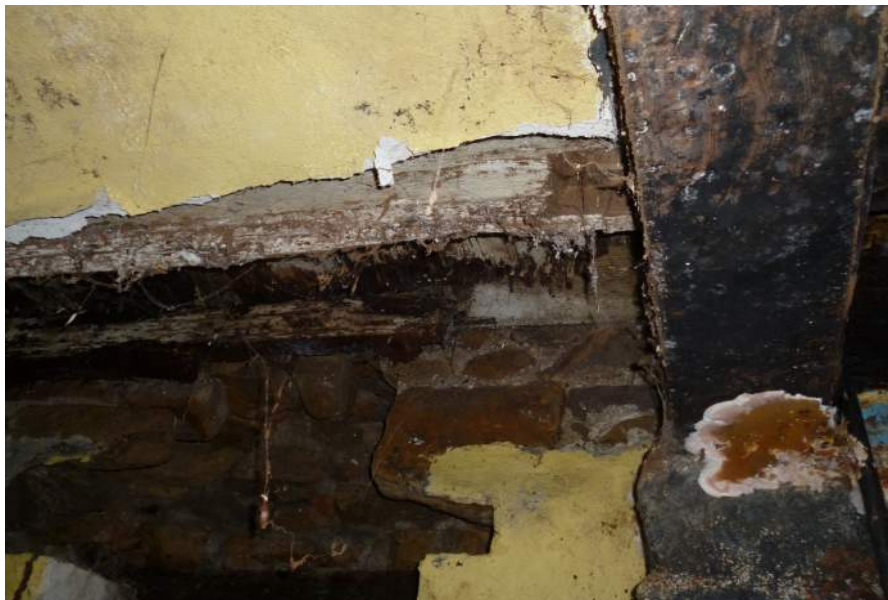
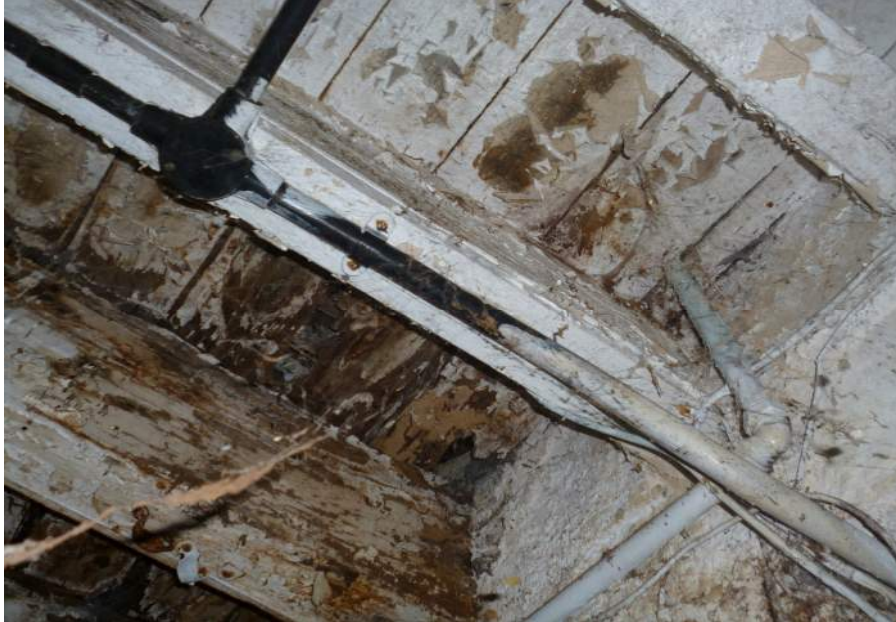
Redecorate	4
005 rear extension lean-to ground floor	Area clearly not in use. Large amount of damp present and currently occupied by rats and pigeons with a build up of droppings. The structure has ongoing water ingress issues, this is effecting the timber floors and masonry walls. Rear wall has cracking and damage to timber beams. The ground floor is concrete with split level due to sloping site. The area is split into 2 sections with a large internal wall buttressing the main building. Some timber joists and floorboards are in very poor condition. NOTE: some boarding to the joists needs inspecting by an asbestos specialist. Floor structure is also made up with steel beams spanning onto the main building. NOTE: first floor was not accessed due to condition not safe to do so. Roof is in poor condition.	Carry out refurbishment and demolition asbestos survey.	1B
		Remove all vegetation from the structure. Interaction with Structural Engineer is required for stability of structure.	1B

Remove roof finishes and inspect all the structure.	1B
		Replace all damaged roof and floor timber and treat remaining under advice from a specialist.	1B
		Investigate cracking.	3
		Carry out crack repairs and remedial works following investigation.	1B
		Re-roof and install new rain water gutter and downspouts.	1B
		Re-render externally including water proofing.	1B
		Replace damaged lintels	1B
		Re-plaster internally.	1C
Install new doors internally and externally.	1C		
005 rear extension lean-to ground floor	With a mixture of slate, profiled metal sheets and an unknown cement/asbestos sheeting. The roof is generally in very poor condition. External area is very overgrown with vegetation growing on the structure - See Photos 520, 521, 524, 523, 469, 470, 473, 475, 476, 477, 478 and 480.

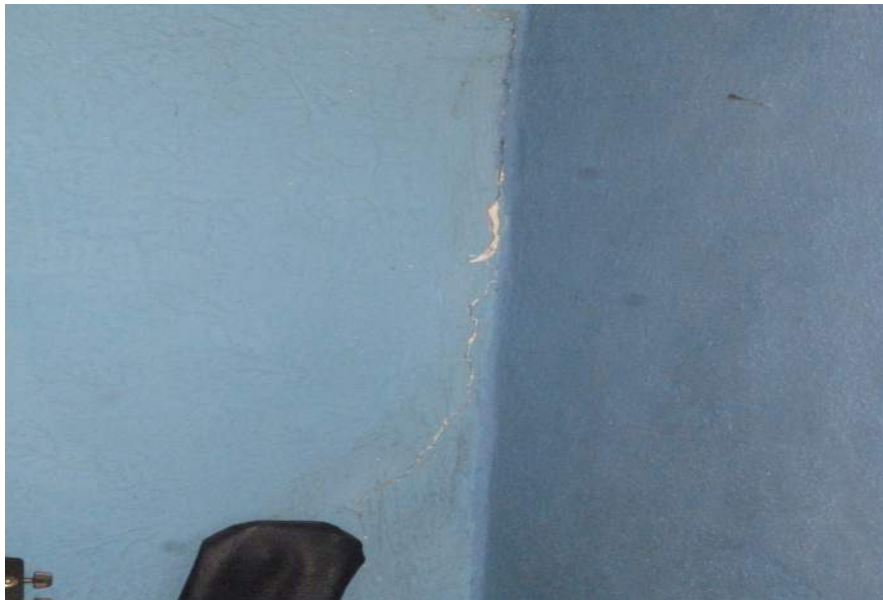
Photo 515

007 Recording room, first floor - old terrace house section.	Timber floor, masonry wall with painted textured finish. Suspended ceiling showing discolouring - possible water ingress. Front elevation cracking in the corner. Photo ref. 515. Roof void NOT accessed.	Investigate water ingress carry out crack repair.	3 2
008 WC, first floor - old terrace house section	Timber floor with slight fall front to back. Plaster walls with textured painted finish. Cracking to rear wall running horizontal above window. Window in poor condition. Photo ref. 514.	Investigate cracking to wall. Carry out crack repair and make good. general re-decorate	3 2 4
009 stairwell - old terrace house section.	exposed timber stairs in poor condition. Painted plaster and masonry walls. Large amount of cracking in all walls. Ceiling cracked and buildings possible water ingress. Photos ref. 509, 510, 511.	Investigate cracking and water ingress. carry out crack repairs following investigation - walls and new ceiling. carry out repairs to stairs decorate	1A 1C 1C 4
