**Units 2a, 2b and 3 White Lund Industrial Estate
Morecambe
LA3 3PB**

Fire Damage Report

Lancaster City Council
February 2021

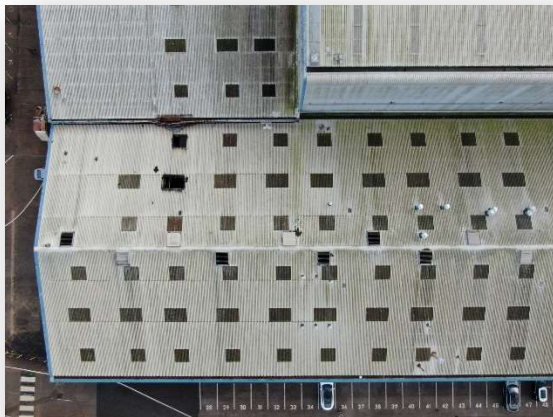
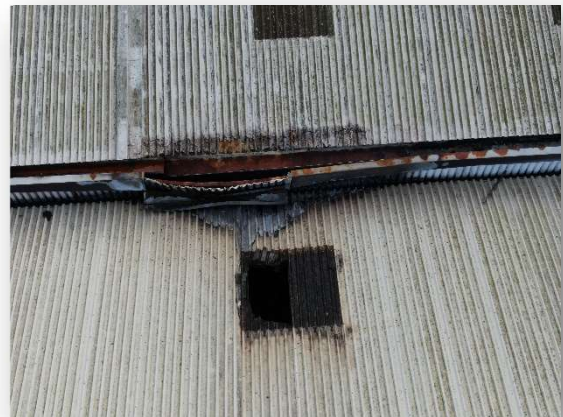
The most severe damage has been caused above the seat of the fire which occurred at the junction of the three units. The images below show the location of the fire and the damage caused to the roof sheets, guttering and roof lights.

Within Unit 2a the underside of the roof covering has been severely damaged by heat and smoke and is beyond economical repair. The GRP roof lights have also been severely damaged by smoke and heat.

The roof covering to Units 2a and 2b requires removing in full and replacement with a new roof covering incorporating roof lights and smoke vents to broadly match the original layout.

Repairs should be sufficient to the damaged roof panels to the edge of the roof and guttering to Unit 3, which can be seen in the photograph to the right-hand side above.

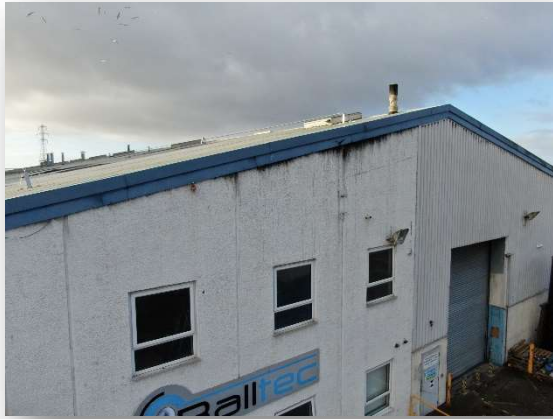
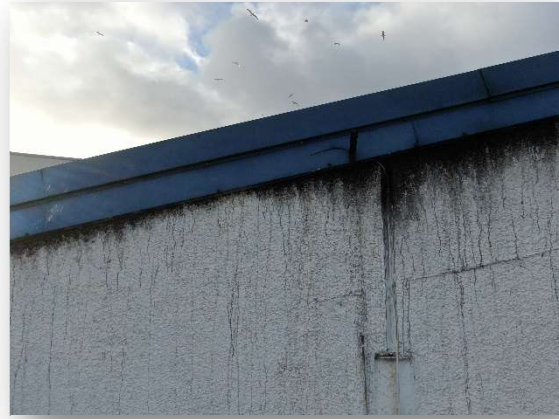
Smoke staining is evident below the verge of the roof to the Northern elevation of Units 2a and 2b where smoke has escaped during the fire.

The stained areas should be professionally cleaned. Redecoration of the gable elevation may be required if a suitable finish can not be achieved by cleaning.

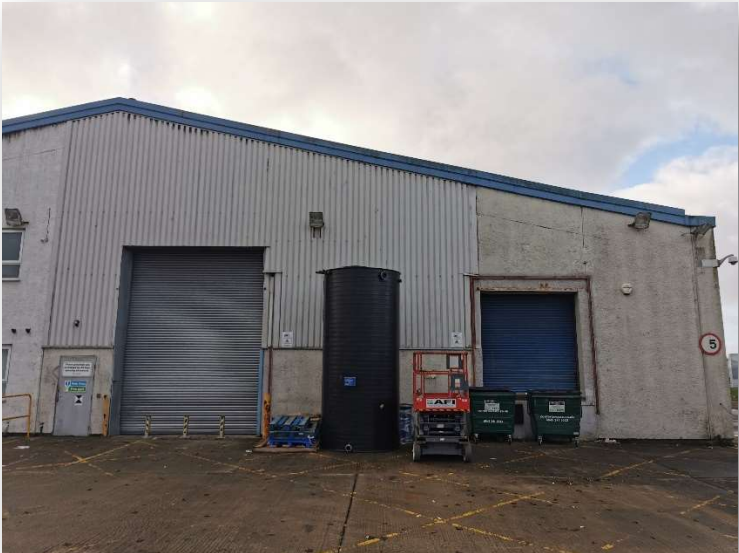
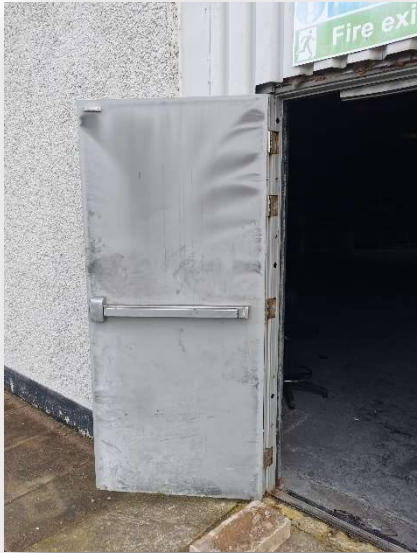
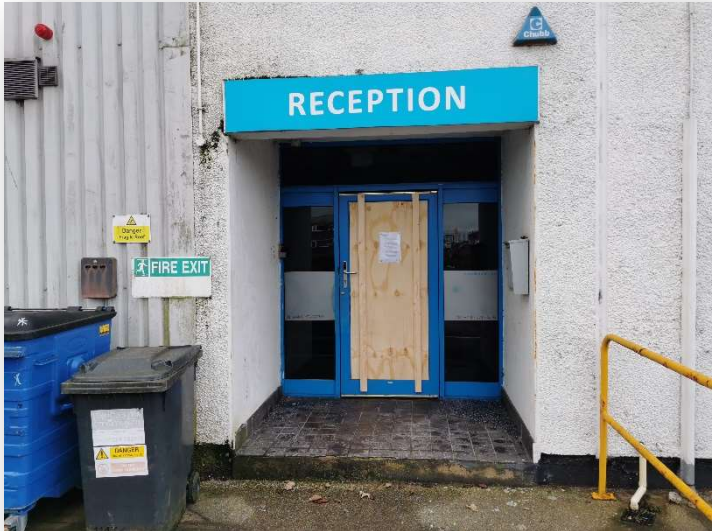
The personnel doors to Unit 2a have been smoke damaged but should be repairable by way of professional cleaning.

The main roller shutter to Unit 2a to the Northern elevation is located in close proximity to the seat of the fire and appears to have been damaged by smoke and heat to the extent that it will require replacement.

The secondary roller shutters to the right hand side of the Northern elevation is smoke stained internally but may be salvageable by way of professional cleaning and servicing.

The main entrance door to Unit 2b has been damaged by the fire service gaining emergency access to the property while tackling the fire. Repairs to the frame and replacement of the glass are required to put the main entrance door back into repair.

The roller shutters to Units 2b and 3 are largely undamaged from the fire and no remedial works are required other than potentially light cleaning down to remove smoke deposits.

Clean smoke damaged personnel doors to all units are required.

Replace glass to main entrance personnel door to Unit 2b.

Replace / repair main roller shutter to Unit 2a.

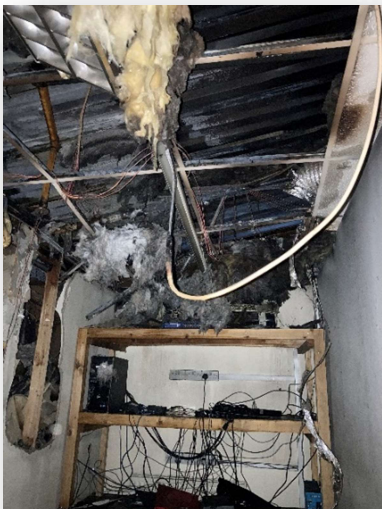
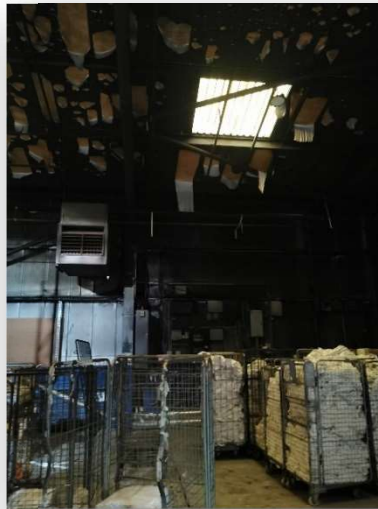
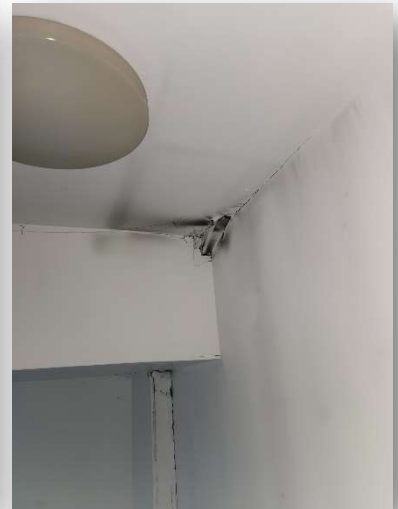
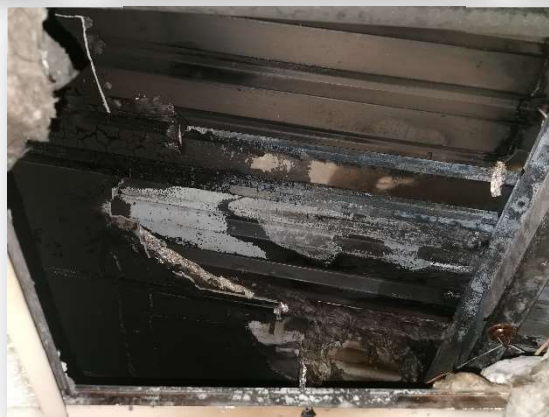
The ceiling within the warehouse section of Unit 2a comprises the underside of the main roof covering. The roof has been extensively damaged by heat and smoke beyond economical repair and requires replacing. Therefore, the replacement of the roof will in effect constitute replacement of the ceiling to the main warehouse areas of Unit 2a.

Within Unit 2b the majority of the ceiling surfaces comprises lay-in grip suspended ceilings with integrated lighting. The majority of the ceilings have been damaged beyond repair by a combination of fire, smoke damage and water damage as a result of the fire service extinguishing the fire. The voids above of the suspended ceiling systems in most areas are also smoke stained so will require professional cleaning once the suspended ceilings are removed.

Withing Unit 3 the warehouse ceiling is soot and smoke stained and requires professional cleaning, particularly to the junction line where Units 2a and 3 meets. Heat damage to the junction of the ceilings was also evident within Unit 3 which will require repairing.

The roof replacement works to Units 2a and 2b will effectively provide a new ceiling to Unit 2a.

The underside of the roof in Unit 3 requires professionally cleaning to remove smoke staining, particularly at the junction where Units 2a and 3 adjoin. Some minor repairs to the underside of the roof in this location way also be required due to heat damage.

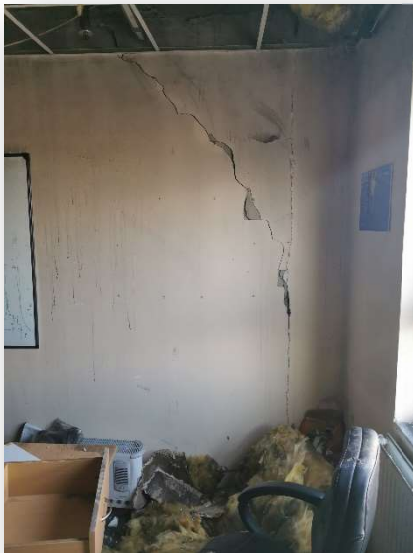
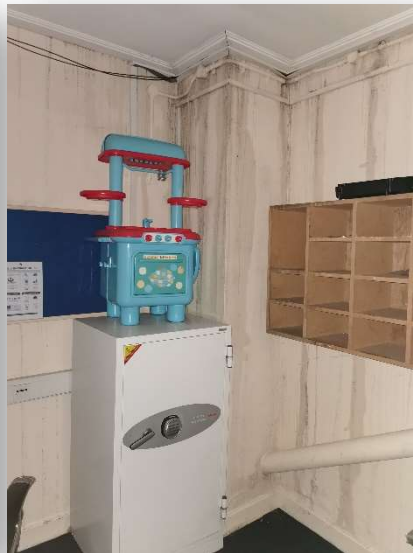
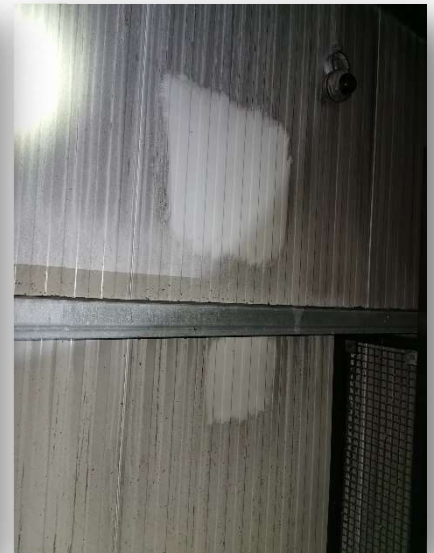
The lining panels have been extensively stained by smoke, in particular to the high level parts of the walls. Some cleaning test panels have been prepared and it appears cleaning of the panels may be possible in some locations at low level.

The concrete blockwork wall which forms a party wall between Units 2a and 2b has been severely damaged by heat and large structural cracks were noted to the wall.

The walls within the majority of the office accommodation to Unit 2b have been damaged by both smoke and water from the fire service. We anticipate that large portions of the wall areas within 2b will require either substantial repair or full replacement / replastering.

The lining panels which are factory coated to the warehouse area of 2a may be salvageable to some areas by way of professional cleaning, however, the most heavily smoke damaged areas are likely to require replacing.

The painted plastered walls to the welfare areas in 2a are lightly smoke damaged so will require cleaning down and redecorating.

The walls to the office accommodation in 2b have been heavily smoke damaged in the areas close to the seat of the fire. Some plastered surfaces particularly to the first floor offices and server room require full refurbishment due to the extensive damage caused by the fire.

Walls within Unit 3 have not been particularly badly damaged and professional cleaning of the walls may be sufficient. Some areas may require redecoration.

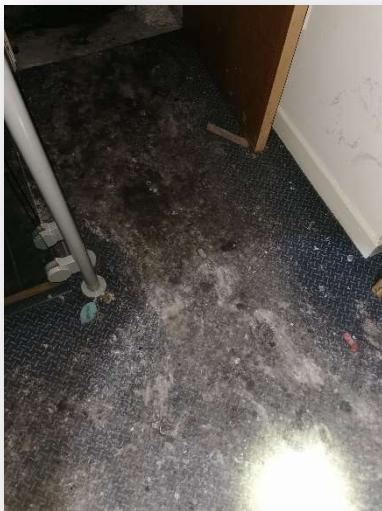
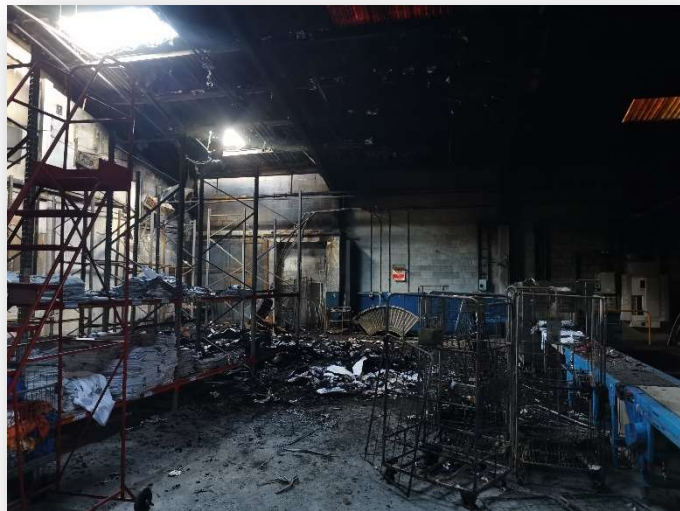
The concrete floor slab at the seat of the fire in Unit 2a is was obscured by burnt debris at to the time of inspection so we were not able to carry out a detailed inspection. The concrete slab may have been damaged by extreme heat and should be inspected once the debris has been cleared.

The other areas of the floor slab within Unit 2a are smoke soiled and require professional cleaning.

Within Unit 2b the majority of the floor coverings comprise carpets. The carpets to all areas of Unit 2b have been damaged beyond economical repair by fire, smoke and water damage. Due to the large volumes of water used to extinguish the fire the floor substrates in units 2b should be allowed to dry sufficiently prior to new floor coverings being installed as part of the general refurbishment works which are required.

Inspect the concrete floor slab in Unit 2a and carryout specialist repairs if required to the concrete where the seat of the fire was located. Professionally clean the floor slab and coverings throughout Unit 2a.

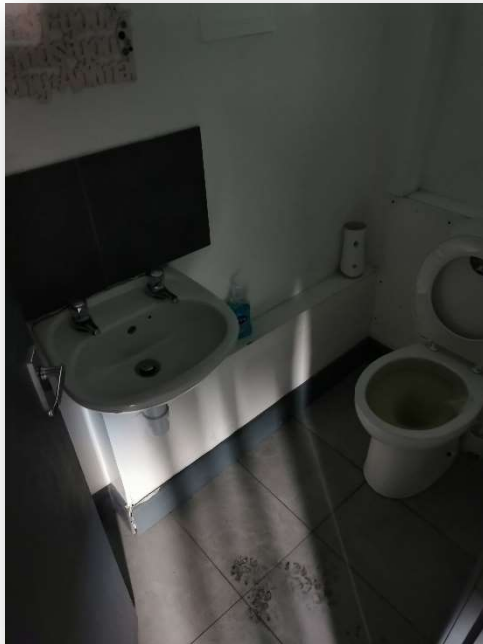
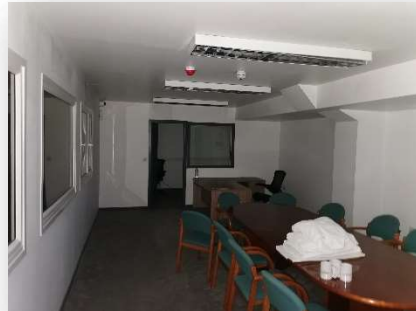
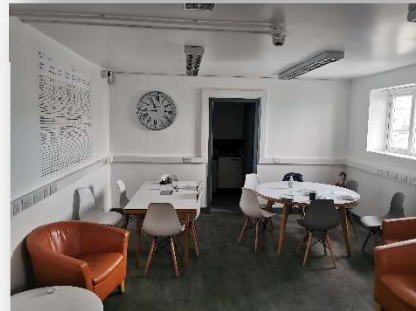
The welfare accommodation within Units 2a, 2b and 3 have suffered some smoke damage and soiling but are generally in salvageable condition subject to professional cleaning and redecoration where appropriate.

Professionally clean down retained surfaces.

Complete plumbing tests to ensure that all water and waste pipework is functioning correctly and is free from leakage.

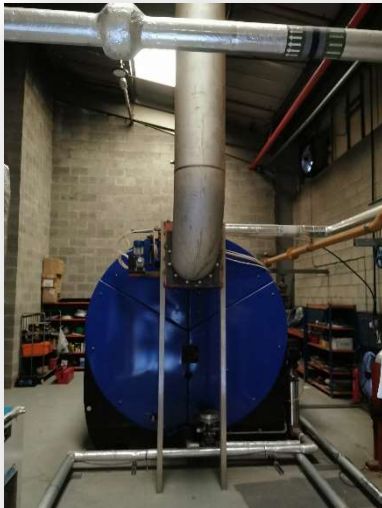
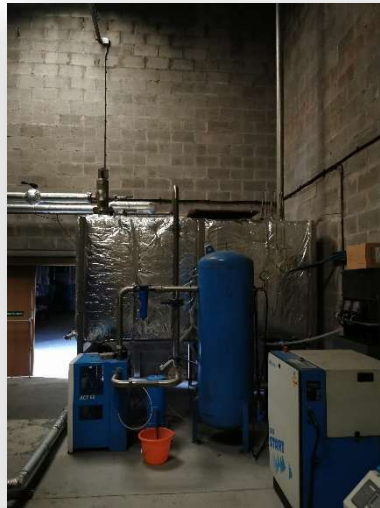
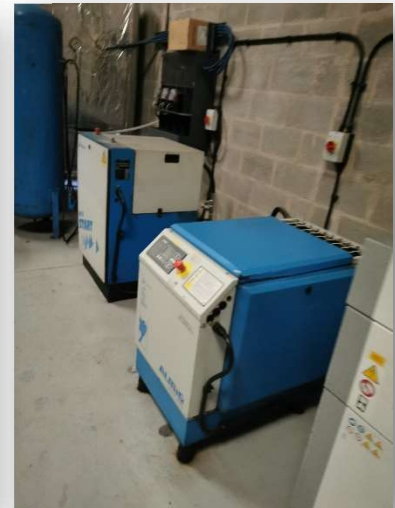
The main plant room within Unit 2a has not been particularly badly affected by fire and smoke damage, however it is not clear if the boiler and other plant equipment has been damaged by heat and smoke. We recommend that a Mechanical and Electrical Consultant engineer is appointed to assess the condition of the retained building services plant.

Other than general cleaning of smoke soiled surfaces no significant works are required in the plantroom in relation to the building fabric.

The underside of the roof has been quite substantially smoke soiled, however, the roof is to be replaced so there is no reason to clean the roof linings on the basis they will be eventually replaced.

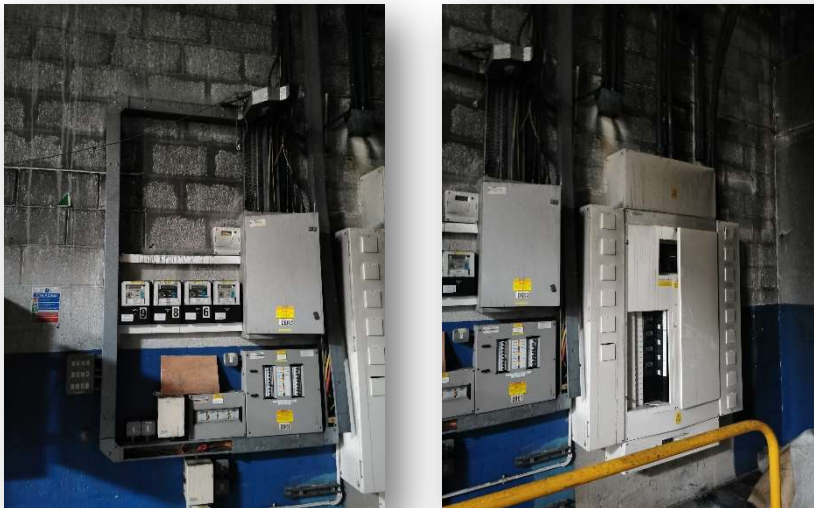
Units 2a, 2b and 3 are all provided with mains electrical power. The power systems to Units 2a and 2b appear to have been severely damaged by the fire.

We anticipate that most of the fixed electrical installations within Units 2a and 2b will require replacing as part of the fire reinstatement works.

We recommend that a Mechanical and Electrical Consultant Engineer is appointed to review the condition of the electrical system and prepare a specification to be incorporated into the main tender package.

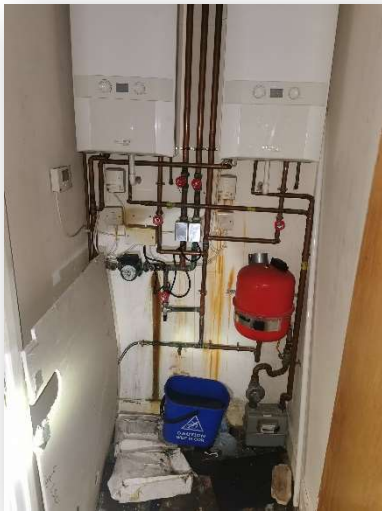
The majority of the warehouse heating plant within Unit 2a and office heating within 2b appears to have been severely damaged by fire / heat.

The main boiler located in the plant room to Unit 2a appears to be in reasonable order and has been relatively well protected due to it being enclosed within the concrete blockwork plant room.

A Mechanical and Electrical Consultant Engineer should be appointed to assess the condition of the systems and establish if any parts are salvageable, for example the twin heating boilers in Unit 2b may be salvageable, however we anticipate that most of the system will require replacement as part of the general fire reinstatement works.

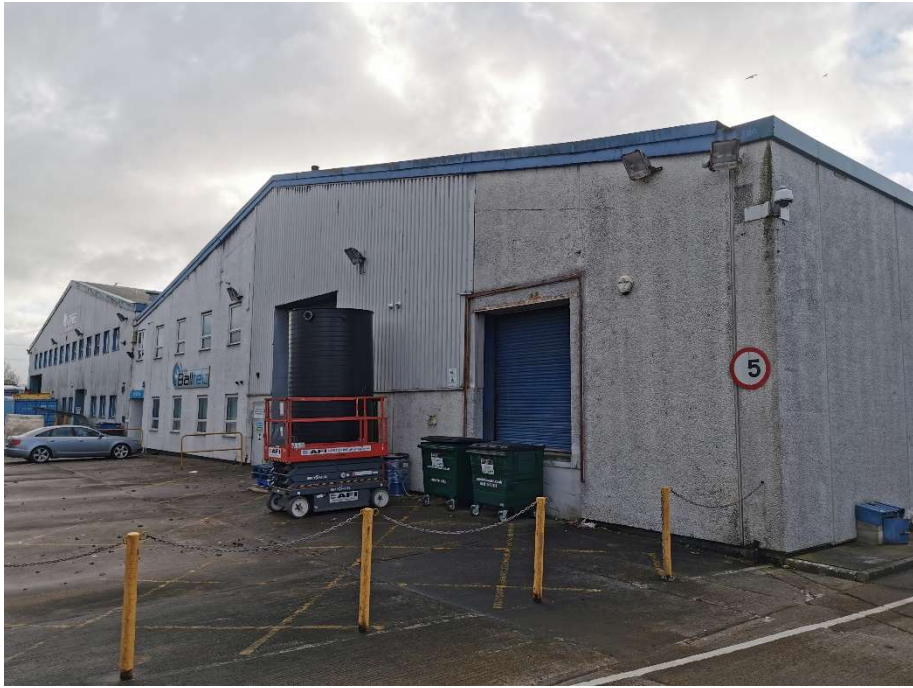
1. Overview of roller shutter entrances to Unit 2a.

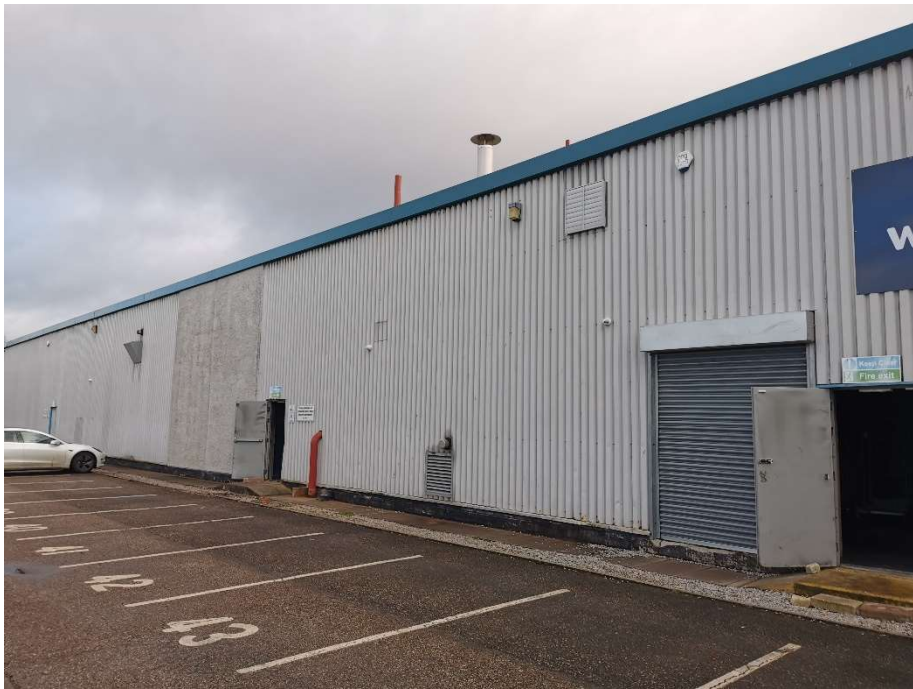
2. Front elevation of Unit 2a.

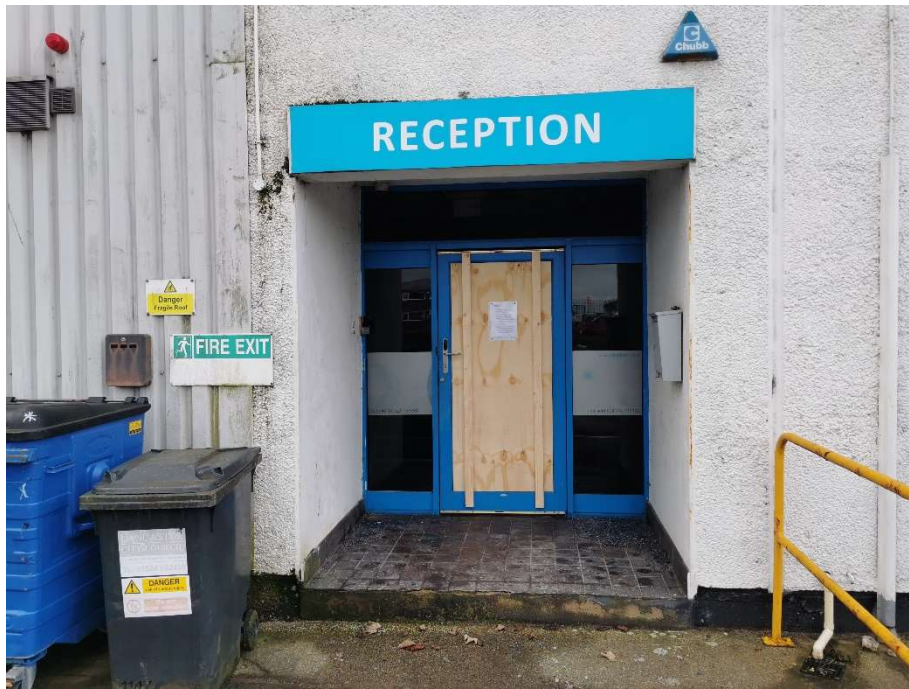
3. Damaged door to Unit 2b.

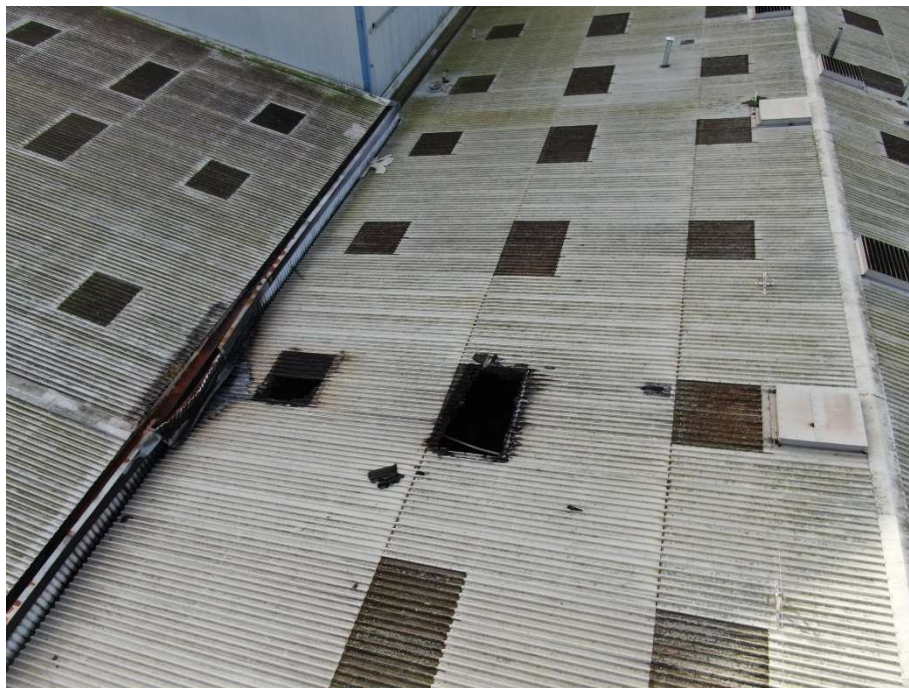
4. Overview of roof showing damage caused by the fire.

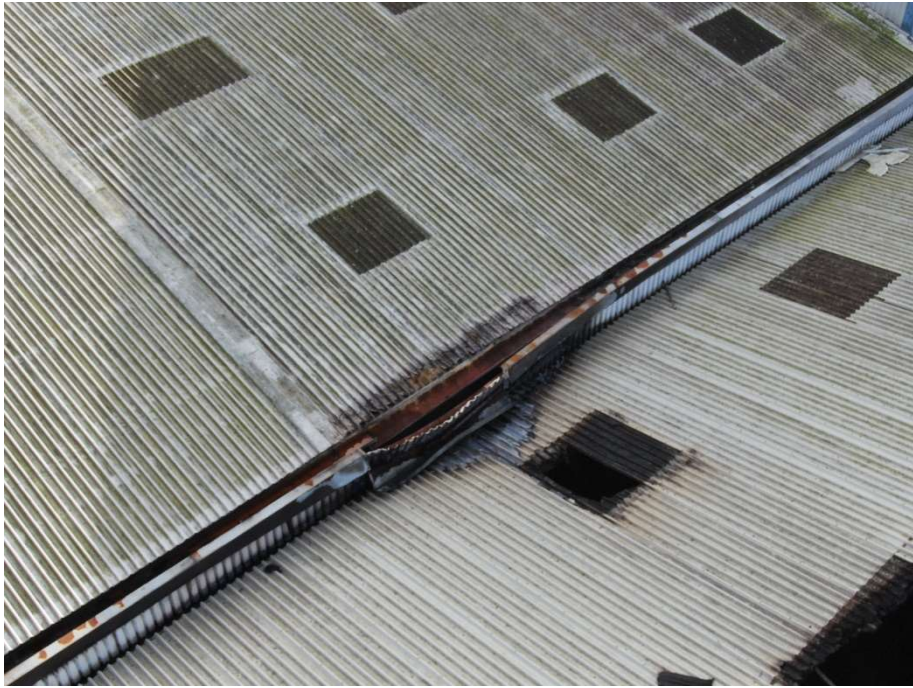
5. Overview of roof showing damage caused by the fire.

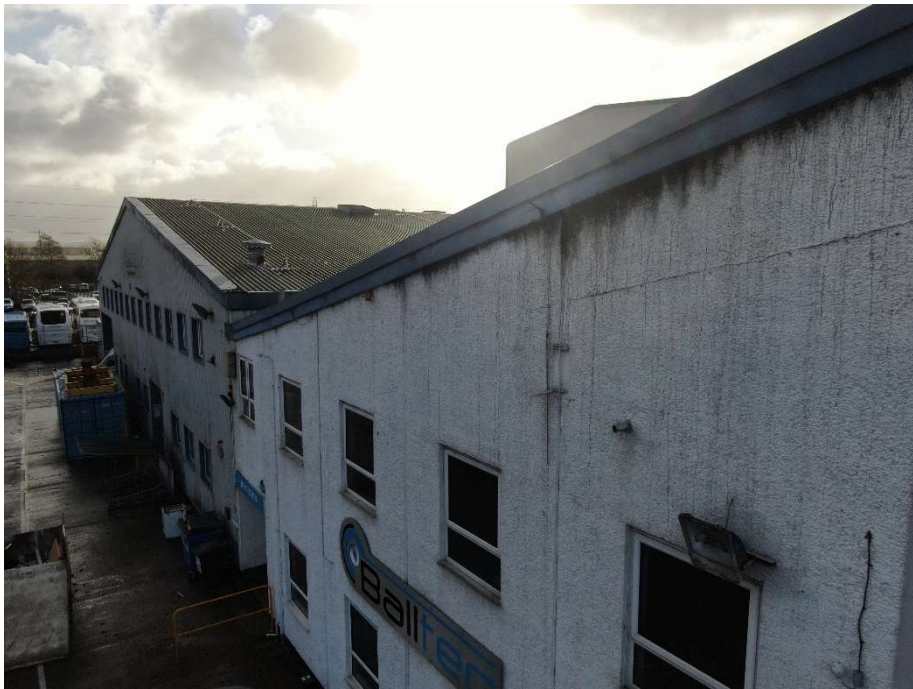
6. Smoke damage below the verge trim.

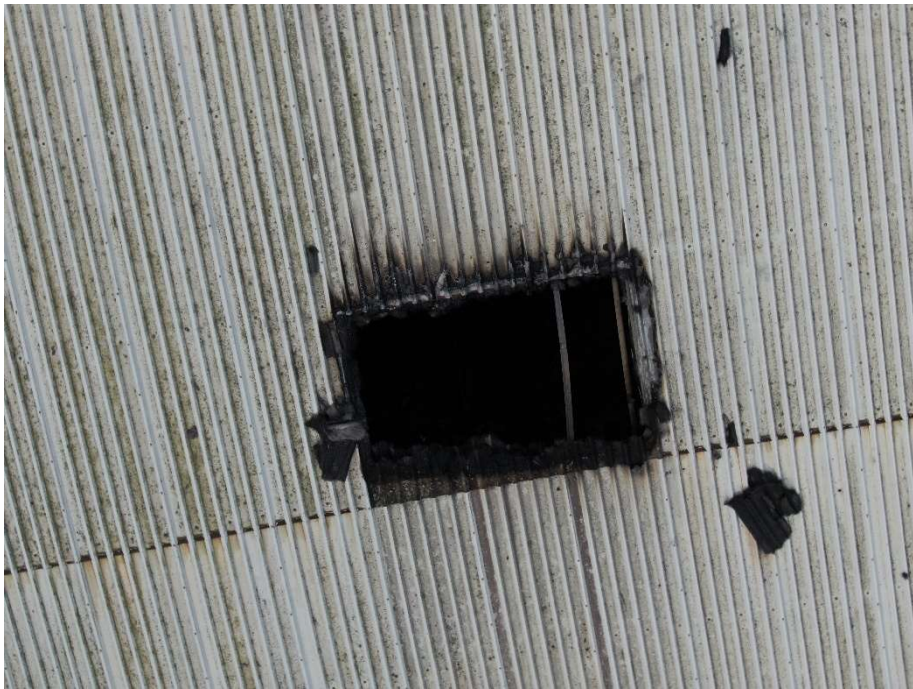
8. Fire damaged caused to the roof.

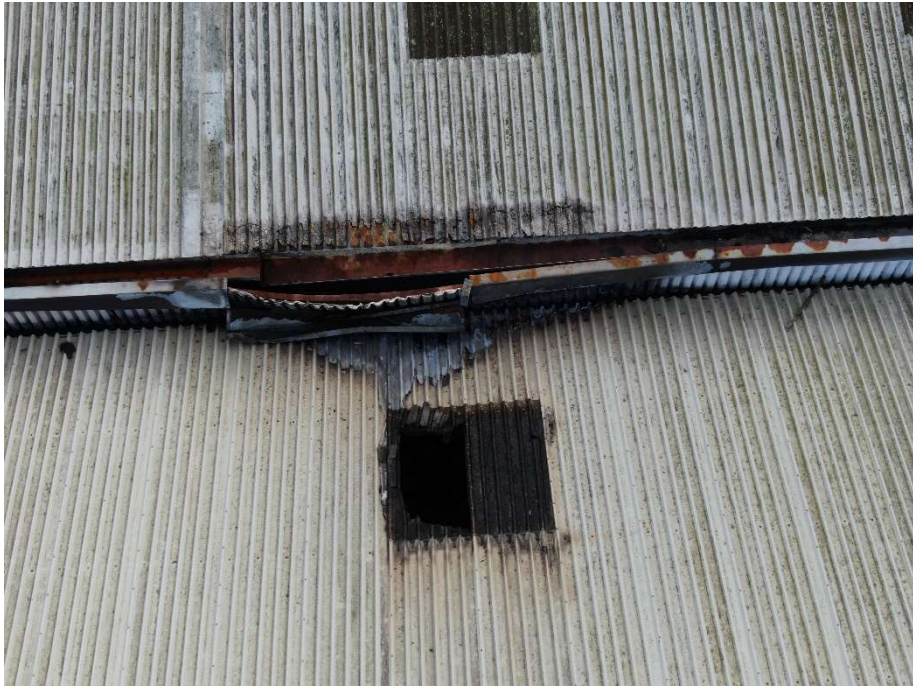
9. Fire damaged caused to the roof.

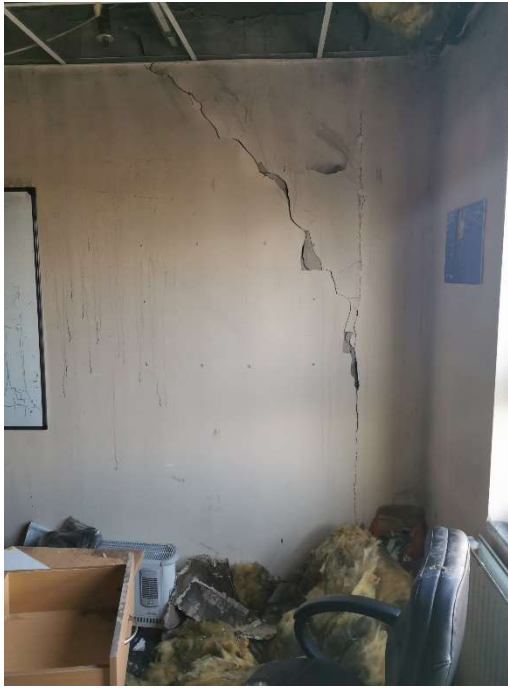
13. Cracking to part wall between units "a and 2b.

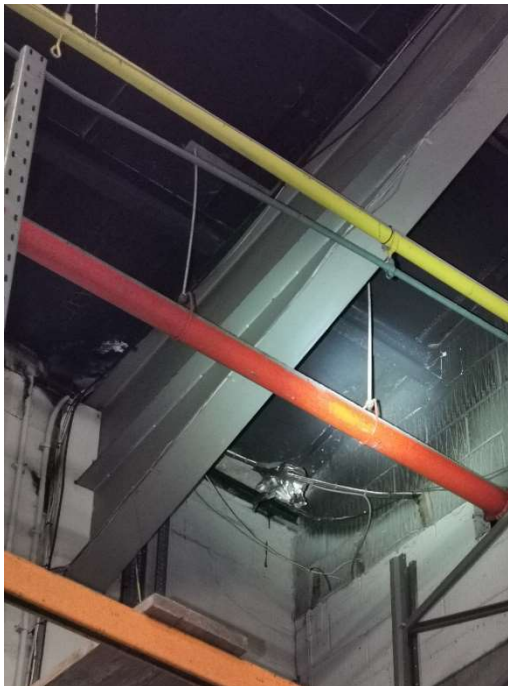
14. Smoke damage to roof in Unit 3.

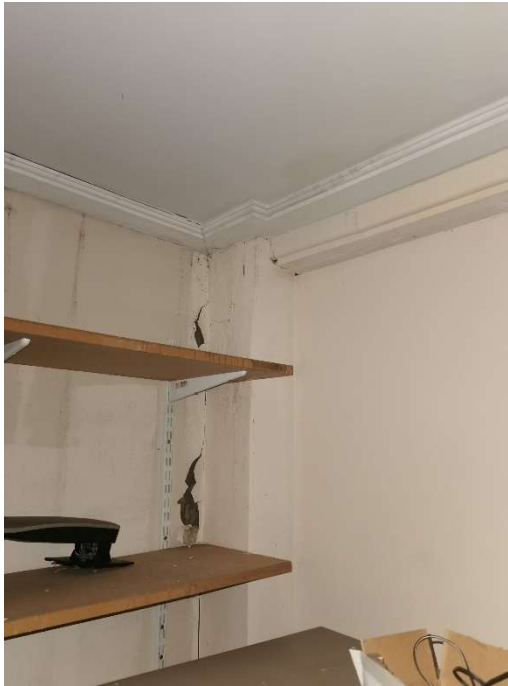
15. Water and smoke damage to Unit 2b at ground floor level.

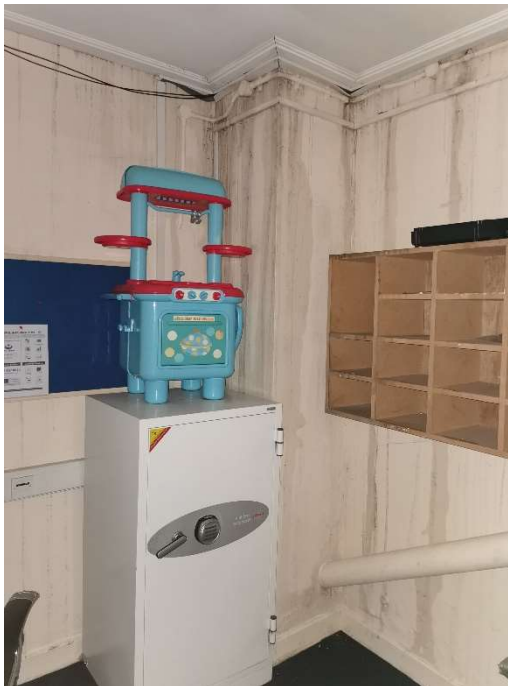
16. Water and smoke damage to Unit 2b at ground floor level.

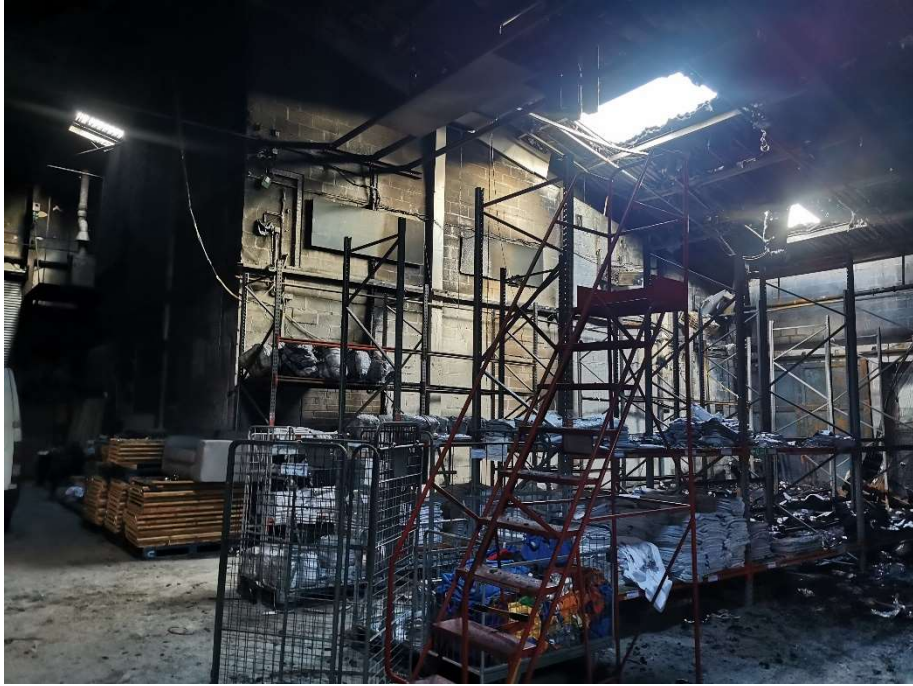
17. General overview of fire damage in Unit 2a.

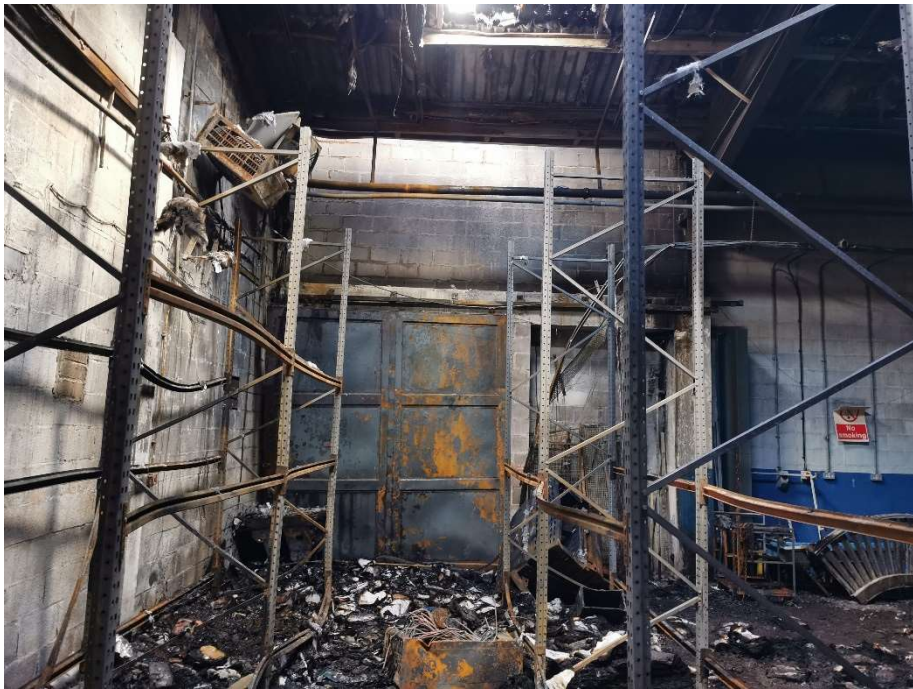
18. General overview of fire damage in Unit 2a.

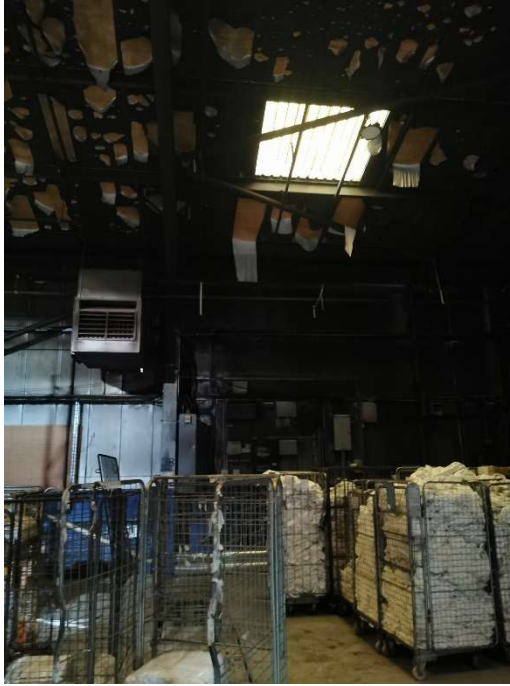
19. General overview of fire damage in Unit 2a.

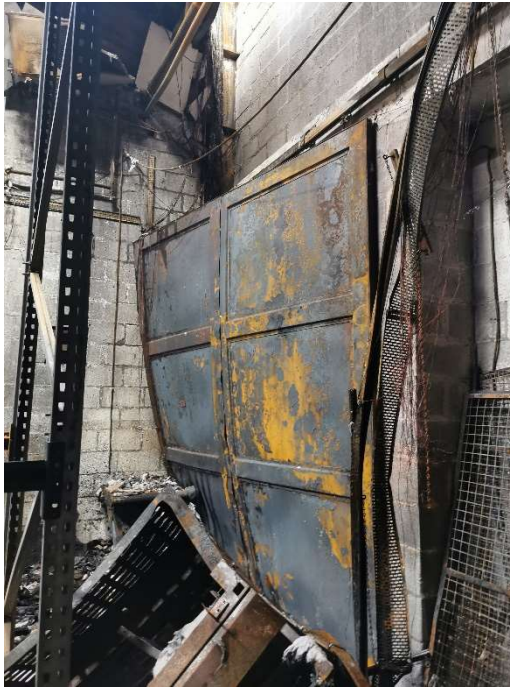
20. General overview of fire damage in Unit 2a.

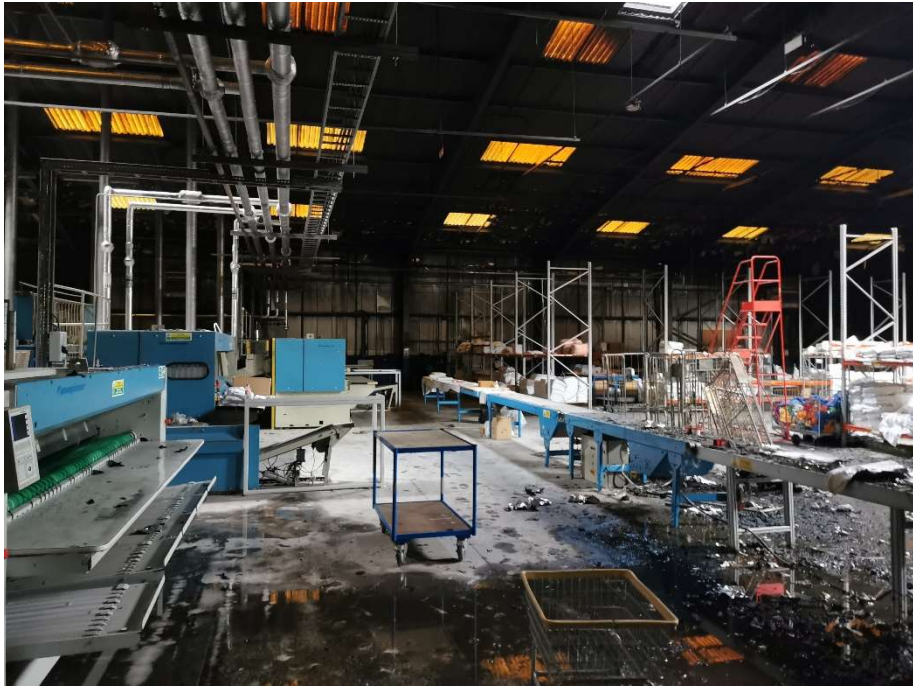
21. General overview of fire damage in Unit 2a.

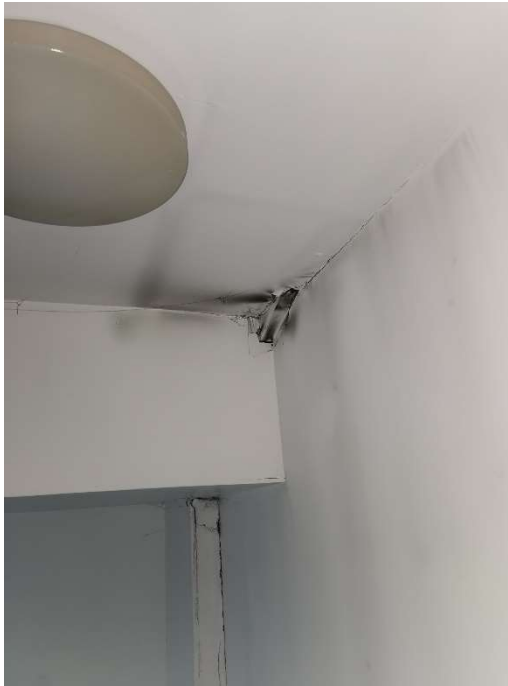
23. Smoke damage to staircase leading up to meeting room in Unit 2a.

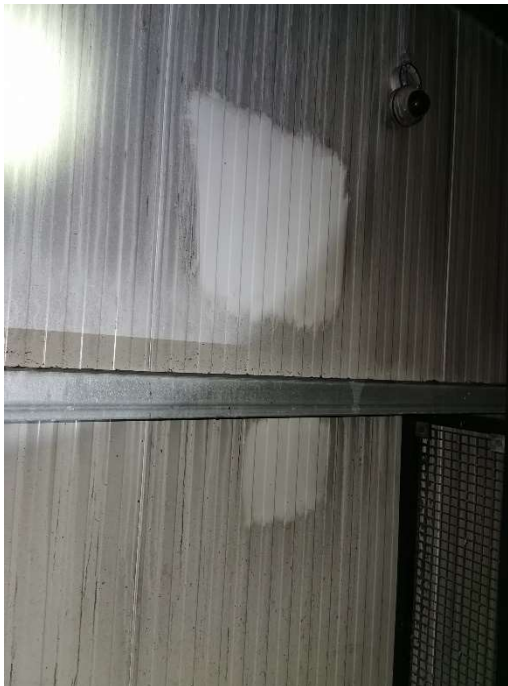
24. Cleaning test panels in Unit 2a.

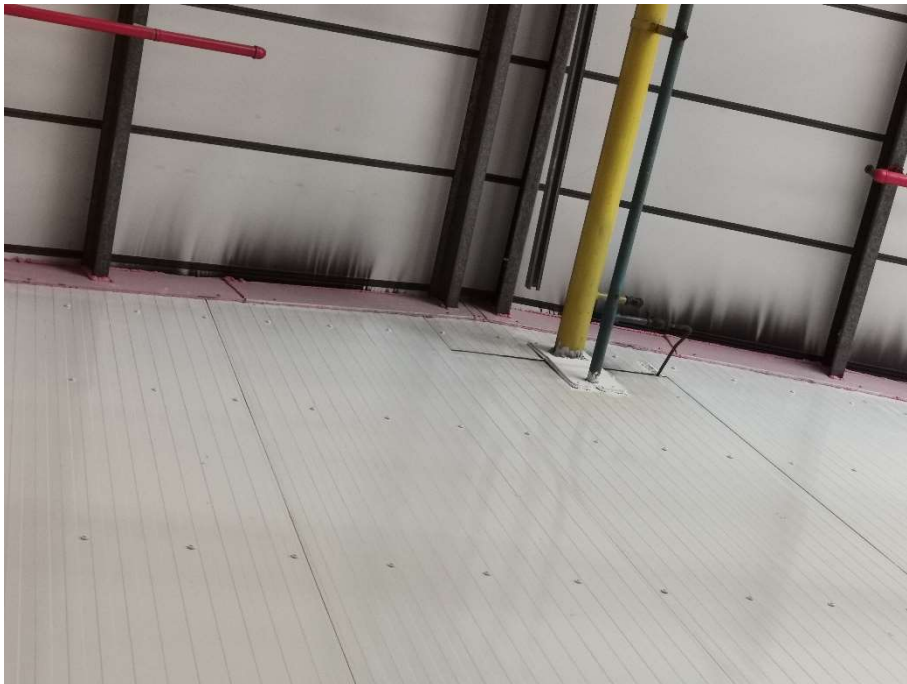
26. Smoke damage to the underside of the roof to Unit 1 at the party wall junction with Unit 2a.
