Glasson Dock

Conservation Area Appraisal

March 2017

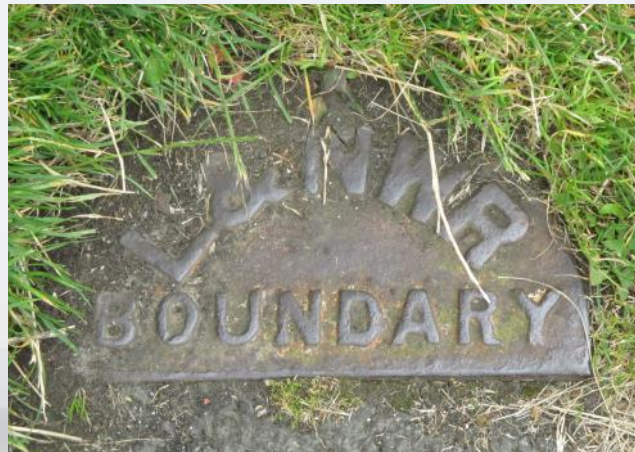
**Fig. 7** London and North Western Railway boundary marker. L&NWR owned the Lancaster Canal and the dock was owned by Lancaster Port Commissioners, this marked the end of L&NWR's ownership.

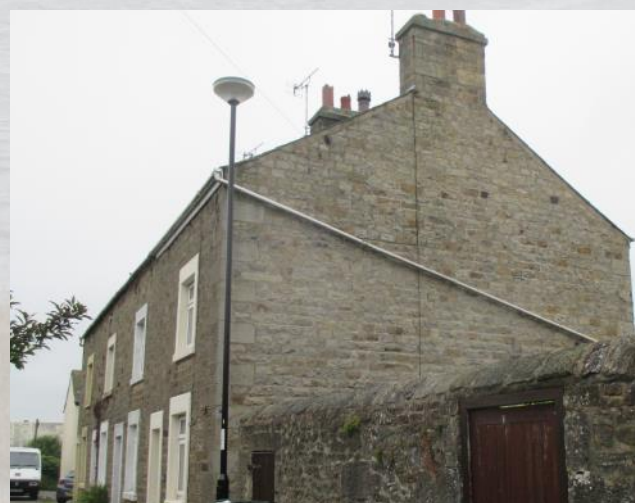
**Fig. 8** West View terrace are late-18th century stone-built houses for shipyard and port workers.

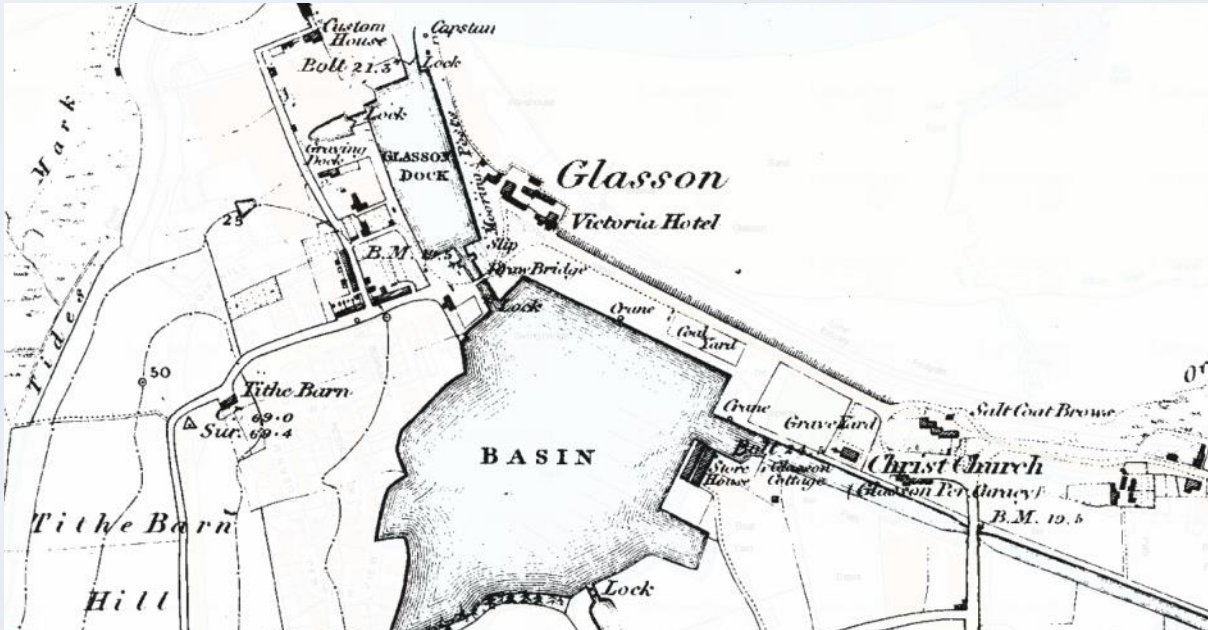
Fig. 12 1840s OS map of Glasson Dock

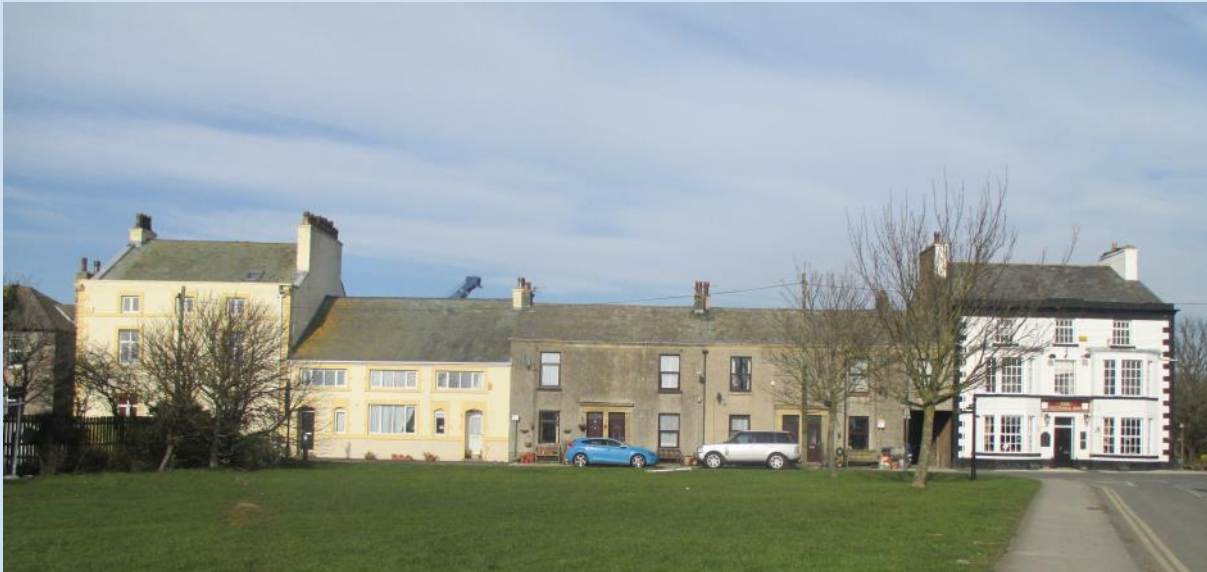
**Fig. 14** Victoria Terrace was constructed in late-18th to mid-19th century. The Caribou, on the left of the terrace, was formerly a pub and potentially one of the oldest buildings in Glasson Dock.

Many buildings in the area date from the late-18th to 19th century, with a mixture of styles and detailing. Along Victoria Terrace, there is a degree of formality in the styles of the buildings. The Caribou and Victoria Hotel have formal arrangement of proportioned stone surrounds of windows. Victoria Hotel has a double height canted bay windows added in the 19th century.

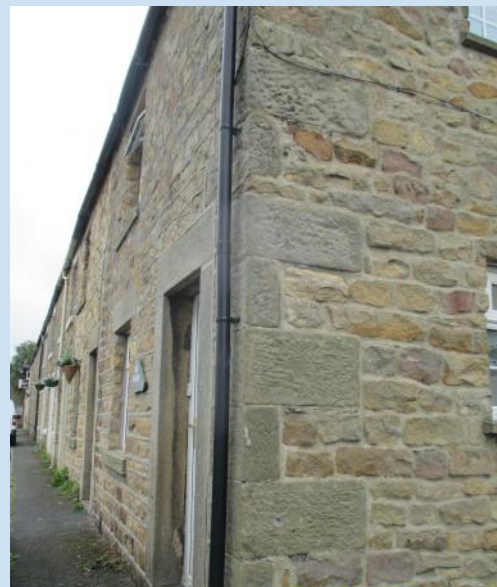
**Fig. 15** View along Tithebarn Hill - buildings face immediately onto the highway.

Near the dock, there is a relatively finer grain and linear pattern to the streets. Predominantly, houses and public houses face immediately onto the highway with some buildings enclosed by a low stone boundary wall. Some historic warehouses remain which have elongated plan form and run perpendicular to the dock, whereas modern 20th century warehouses have a large mass and footprint and dominate the surrounding land of the dock. Buildings become much more scattered next to the canal and Brows Bridge.

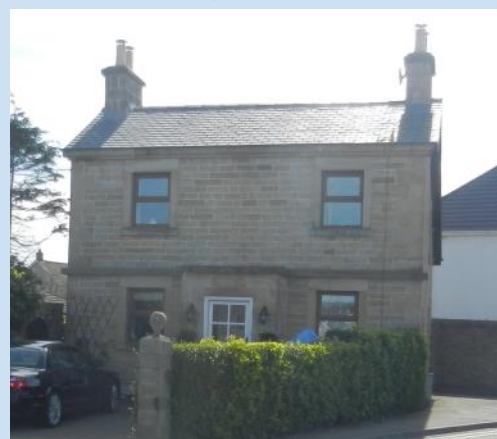
**Fig. 16** Lock Keeper's Cottage - a detached early-19th century house.

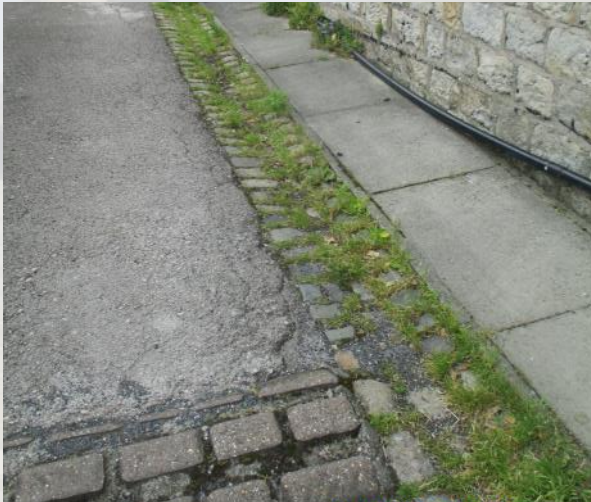
In general, the streets of Glasson Dock are of tarmac and are lined with pavements which are also of tarmac with a stone kerb. However, along West View there is still some cobbles retained along the street which gives an indication of the surfaces of the past.

**Fig. 17** Cobbles retained along West View add historic interest to the streets in Glasson Dock.

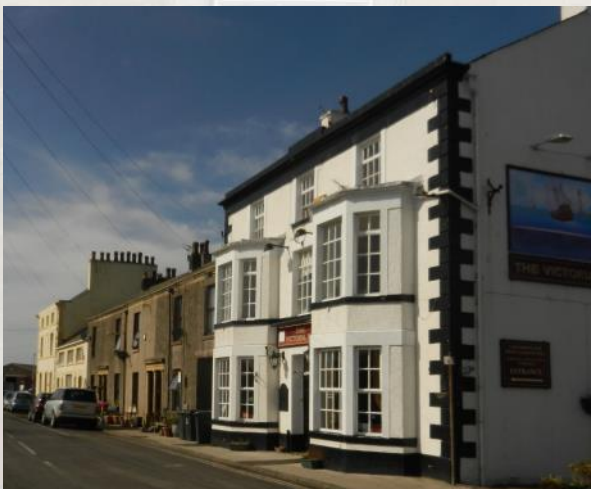
Sandstone is prevalent within the conservation area of Glasson Dock, it was used for the dock, buildings and boundary walls up to the 20th century. Stonework is predominantly coursed sandstone with finer detailing seen on buildings such as the Vicarage, to rougher dressed stone on terraces along Tithebarn Hill. The stonework and quoins are often left exposed, but there are also some examples of rendering. For example along Victoria Terrace, buildings are a mix of stucco and roughcast render.

**Fig. 19** View of Victoria Hotel, a grade II listed public house, which dates from the 19th century which has a smooth render finish.

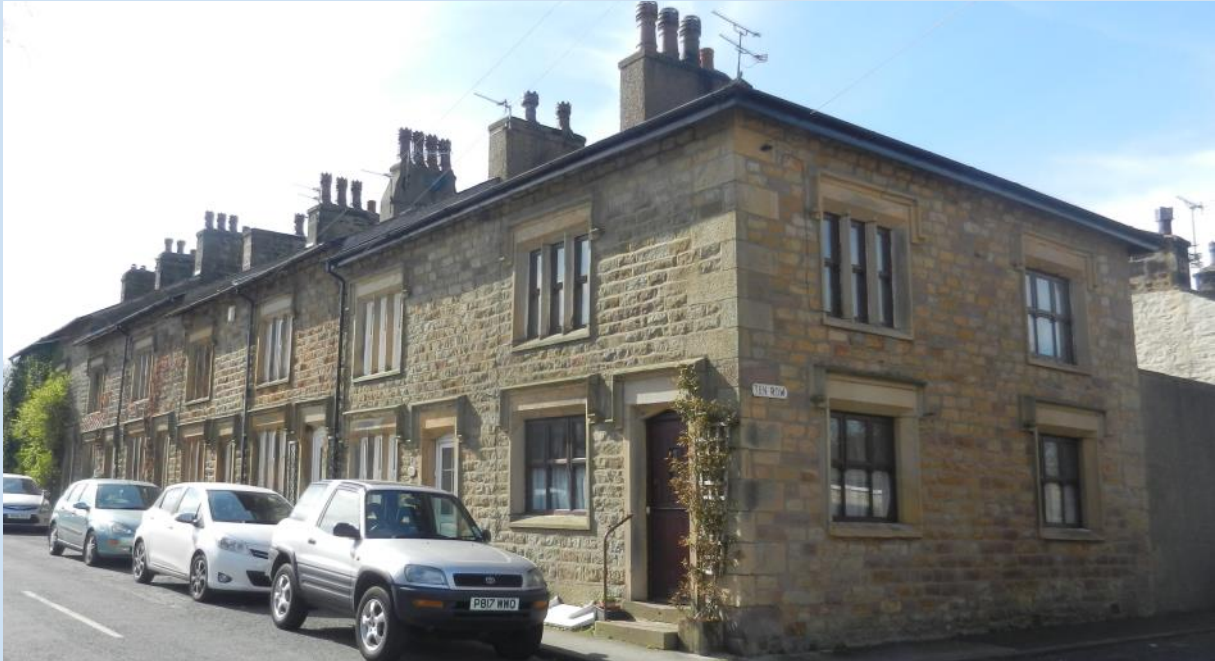
**Fig. 20** 20 - 34 Tithebarn Hill are terraced houses designed in mock-Tudor style. There has also been much unsympathetic alteration to windows and doors.

20 - 34 Tithebarn Hill have an unusual free 'Gothick' style with the stone mullioned windows with label-stop hood mould and a Tudor arch above the door. In comparison, those houses at 2-18 Tithebarn Hill, along West View, Ten Row and Railway Place have a more vernacular style influenced by the function rather than form. These either have simple stone surrounds or lintels to doors and windows. There has been some retention of original cast iron rainwater goods in some areas.

Historically, windows were timber sliding sash and doors were timber panelled doors. Although there has been Article 4 Directions in place since 1981 along Tithebarn Hill and Victoria Terrace, the area has seen a significant amount of unauthorised upvc replacement windows and doors and satellite dishes installed along the front elevation. These have severely detracted from architectural significance, thus undermined the historic interest in many of the buildings.

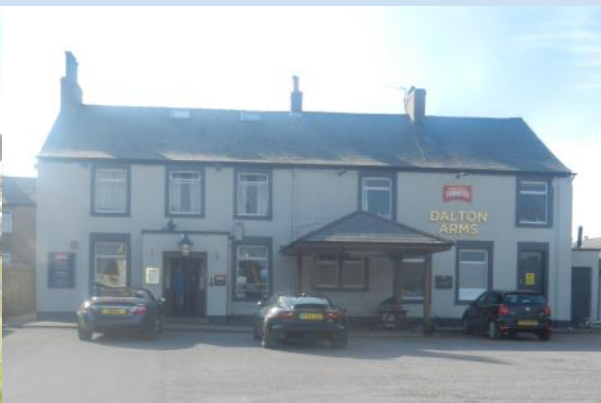
**Fig. 22** The Dalton Arms, is a converted terrace of houses into a public house.

Terraced houses, such as Tithebarn Hill and Ten Row, date from the late-18th to early-19th century and were built to accommodate the growth in dock workers. This part of the settlement also includes a Lock Keeper's Cottage and the Dalton Arms, a late-18th century terrace converted to a public house. Many houses and public houses, such as those along Victoria Terrace, date from the early to mid-19th century. The Caribou, originally known as Pier Hall, is speculated to be one of the oldest buildings in Glasson Dock as it got its first licence in 1781.

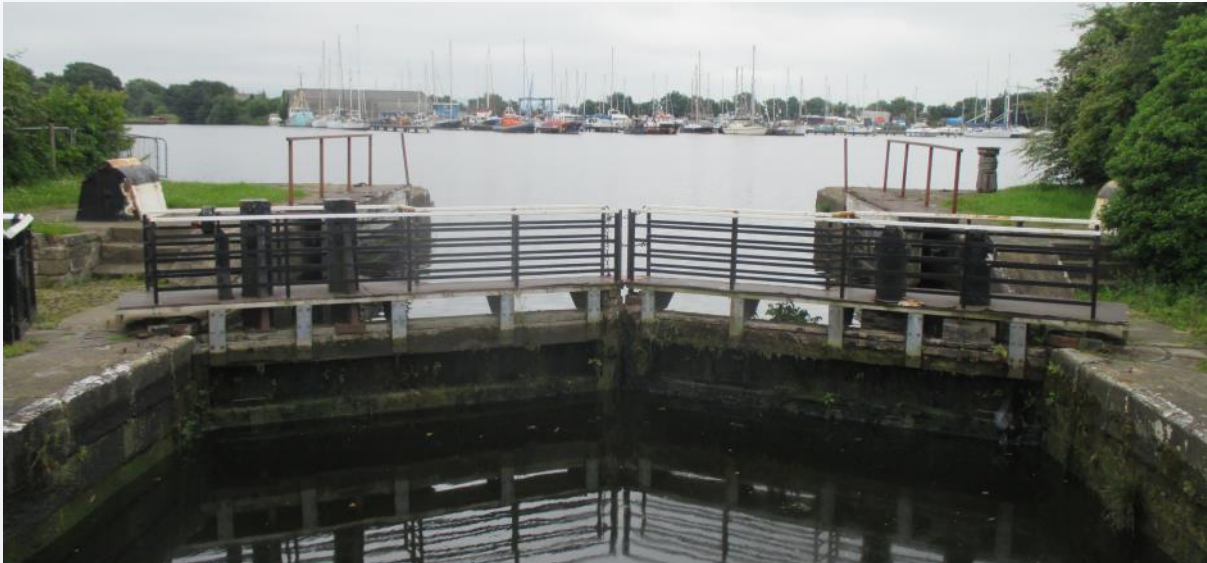
**Fig. 23** Lock of Glasson Dock which leads to the canal basin. The locks have solid masonry walls with a modern swing bridge across.

Within the conservation area, there is a scheduled monument which is protected under the Ancient Monuments and Archaeological Areas Act 1979. The scheduling covers a rare surviving example of a late-18th and 19th century commercial dockyard. As seen in Fig. 5, the scheduled area includes the wet dock which was constructed in 1800, the East pier, pier head, graving dock and lock entrance to the canal basin.

The area largely remains in use for trade, but as a result has become dominated by modern late-20th century warehouses. In addition, the graving dock has been infilled to be a car parking area, which erodes its significance. Nonetheless, the site provides evidence of the historic development of the area and is a potential resource for future archaeological research or interpretation.

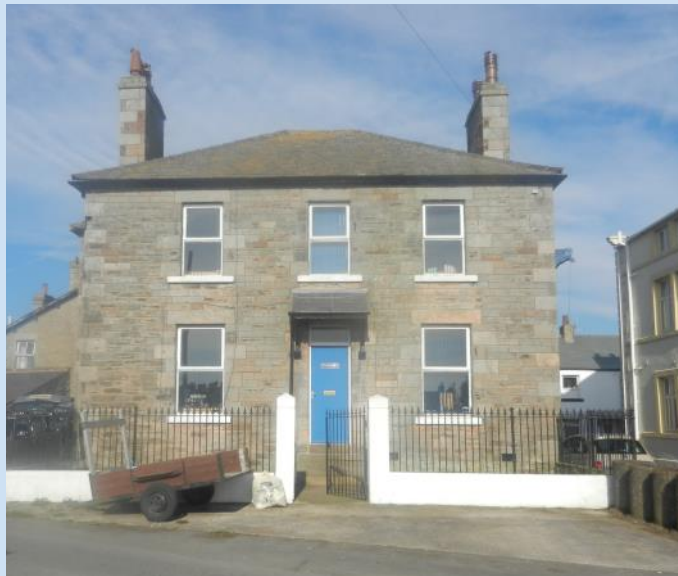
Fig. 25 Harbour House along Victoria Terrace dates from 1800.

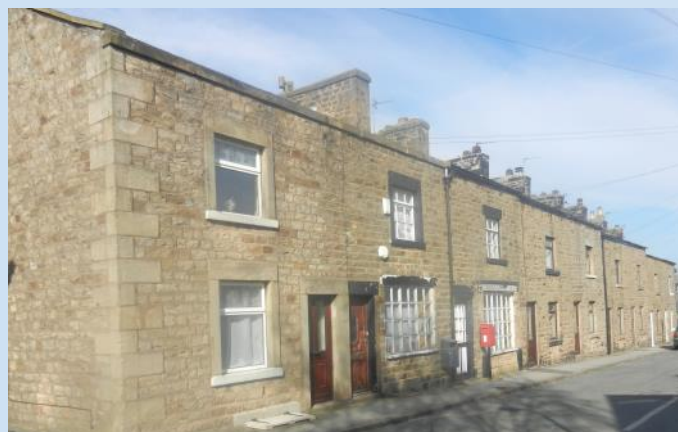
Fig. 26 2 - 18 Tithebarn Hill was constructed in the late-18th century. Some of the houses had shopfronts and used a post office, but returned to a house.

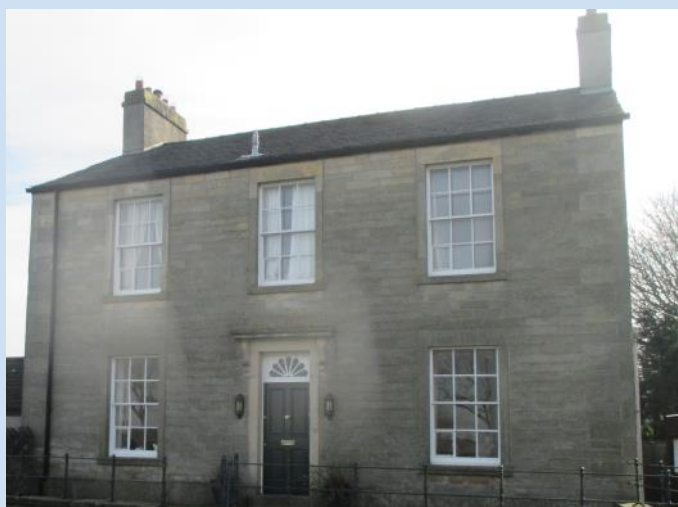
Fig. 27 The Vicarage is a late-19th century house in connection to St John's Church, has retained its 6-over-6 sash windows and timber panelled door with fanlight.

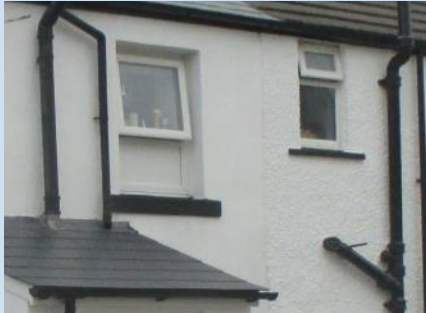
**Fig. 29** Inappropriate top hung uPVC windows have a negative impact on the area.

In some buildings, traditional windows and doors have been replaced with uPVC alternatives or have inappropriate dark stained timber rather than traditional paint finish. In addition, the openings have been significantly altered with these modern alternatives. Traditionally, windows were sliding sash and often been replaced with top-hung casement openings. These non-traditional doors and windows negatively impact the character and appearance of the buildings, which subsequently has a detrimental impact on the special interest of the conservation area.

To prevent and mitigate further inappropriate alteration and development, a design guidance notice document could be provided to those properties subject to an Article 4 Direction. This could advise what would require planning permission and indicate what changes would be looked upon favourably. A consultation event could be held to promote awareness of conservation issues.
