Appendix 2 – Co-Op Building Details, Photographs and Plans

The Co-Op Building, also more formally known as Centenary House is located on Regent Road in the West End of Morecambe.

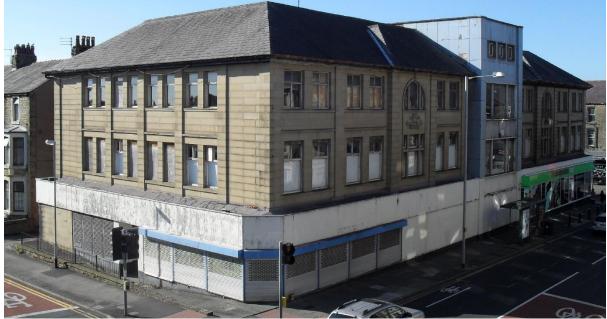
Photograph of Westminster Road and Regent Road elevations

The building is of steel framed construction, with load bearing masonry walls, flat and pitched profiled roofs, cast iron gutters and downspouts, predominantly stone and brickwork elevations and timber windows. The original entrance feature consists of mosaic tiling and vertical timber cladding.

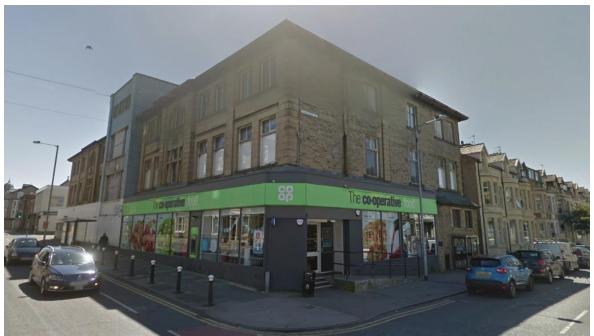
Photograph of Clarendon Road and Regent Road elevations

The central main entrance is on Regent Road (boarded up) and leads to a central stair to all floors. Either side of the main stairs is a customer lift and a goods lift, both of which are inoperable. The building is laid out with all services to the rear of the building including utilities, offices, kitchen and toilets etc. The majority of internal area is the former retail floor space and is quite open with the only restriction a series of supporting pillars.

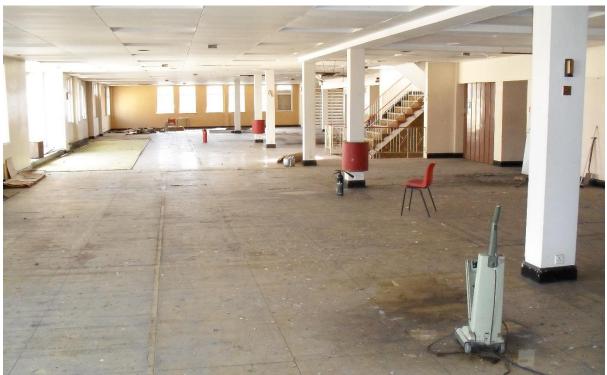
Photograph of first floor former retail space
