MUSICIANS CO-OP

CONDITION REPORT

Our ref: L35353/SW/TP

**MUSICIANS CO-OP
LODGE STREET
LANCASTER**

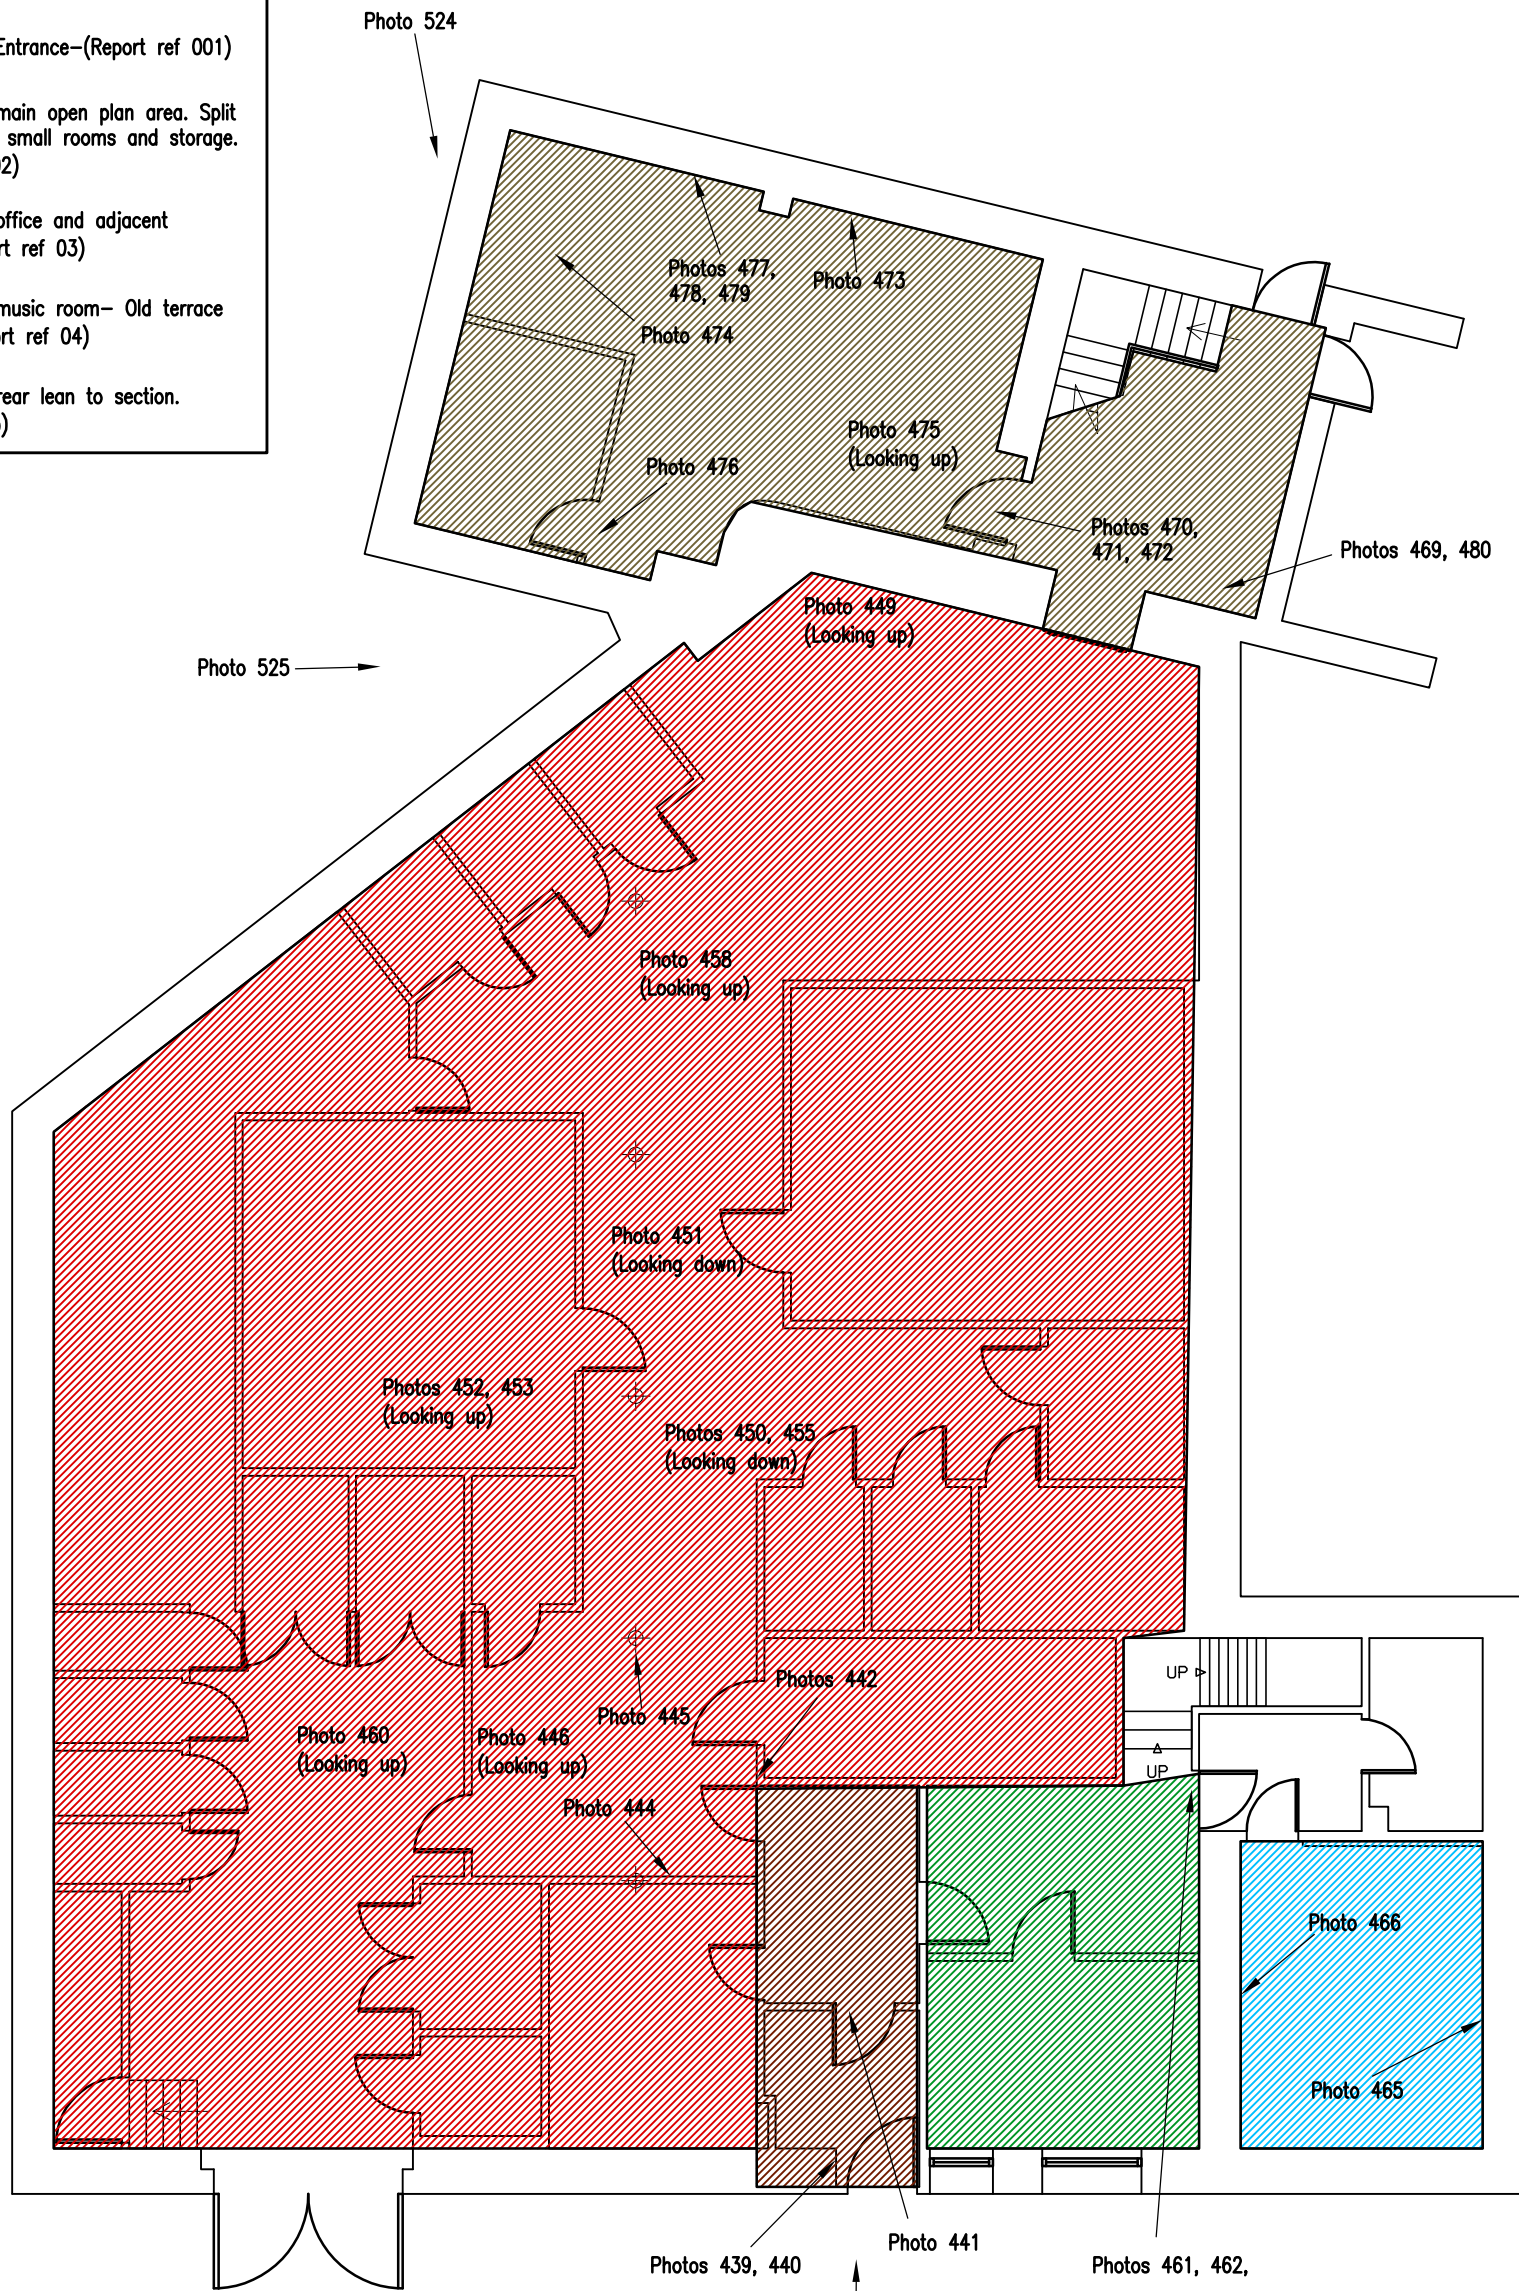
GROUND FLOOR PLAN

- Ground Floor Entrance—(Report ref 001)
- Ground Floor main open plan area. Split with studs for small rooms and storage. (Report ref 002)
- Ground Floor office and adjacent hallway. (Report ref 03)
- Ground Floor music room— Old terrace building. (Report ref 04)
- Ground Floor rear lean to section. (Report ref 05)

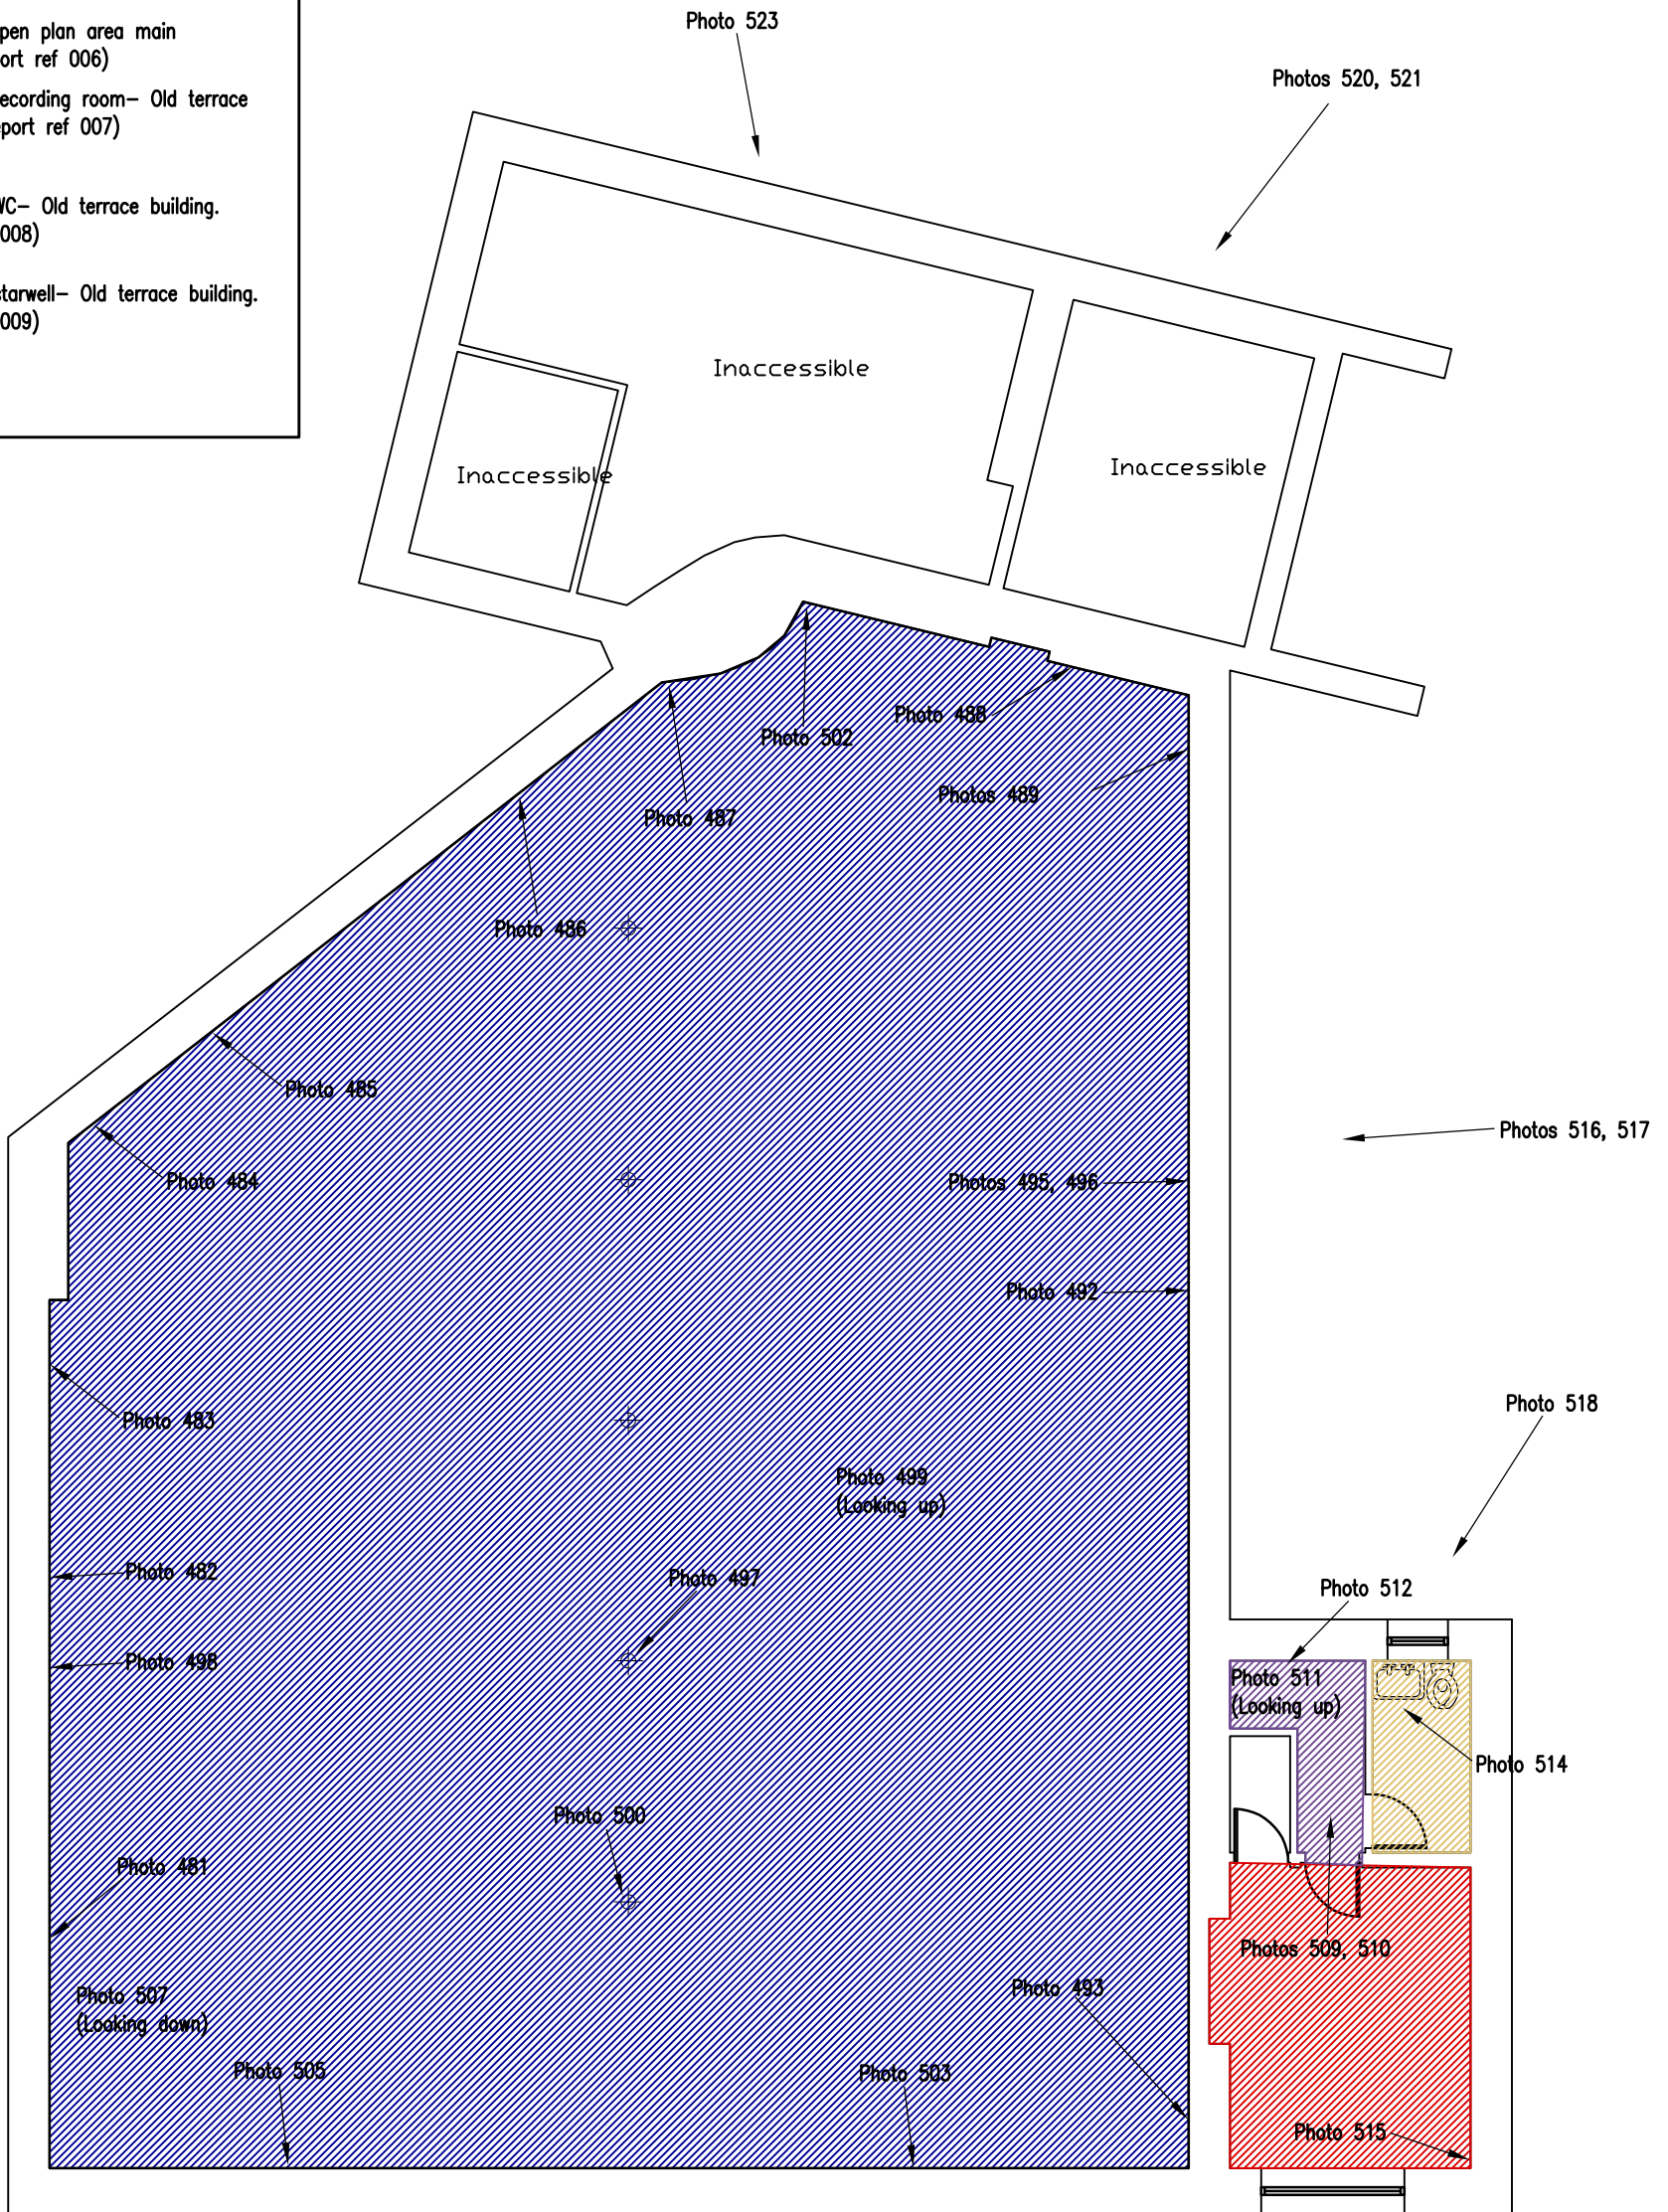
FIRST FLOOR PLAN
DO NOT SCALE

First Floor stairwell- Old terrace building. (Report ref 009)

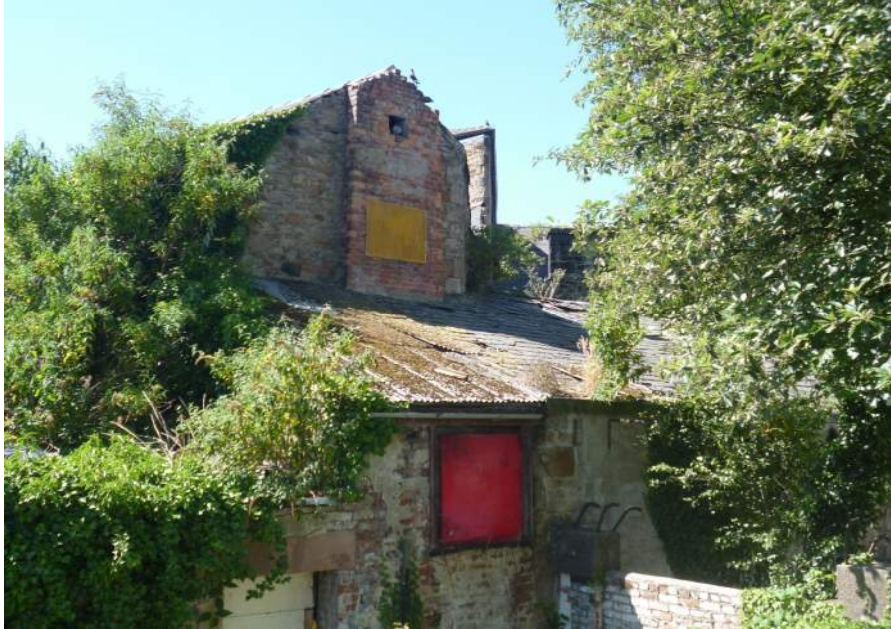
Photo 521

Remove roof finishes and inspect all the structure.	1B
		Replace all damaged roof and floor timber and treat remaining under advice from a specialist.	1B
		Investigate cracking.	3
		Carry out crack repairs and remedial works following investigation.	1B
		Re-roof and install new rain water gutter and downspouts.	1B
		Re-render externally including water proofing.	1B
		Replace damaged lintels	1B
		Re-plaster internally.	1C
Install new doors internally and externally.	1C		
005 rear extension lean-to ground floor	With a mixture of slate, profiled metal sheets and an unknown cement/asbestos sheeting. The roof is generally in very poor condition. External area is very overgrown with vegetation growing on the structure - See Photos 520, 521, 524, 523, 469, 470, 473, 475, 476, 477, 478 and 480.
